PRELIMINARY STRUCTURAL CONDITION ASSESSMENT

14 Elizabeth Walk – the former “Reel 2
Reel Theatre”

The City of Elliot Lake has retained TULLOCH Engineering to conduct a preliminary structural condition assessment (PSCA) of a commercial property located at 14 Elizabeth Walk, Elliot Lake, Ontario, formerly known as the “Reel 2 Reel” Theatre. The field assessment was conducted on June 10, 2022 with the intent to gather facts to submit a report outlining the overall condition of the structure and any issues related to the structure warranting immediate repair, replacement or remediation. In addition, TULLOCH is providing structural engineering services to support the planned renovation of the Theatre. Where discoveries were made that could affect the renovation as planned, they have been made known in the following report. Observations and photographs drawn from two site visits in April 2022 are included where relevant.

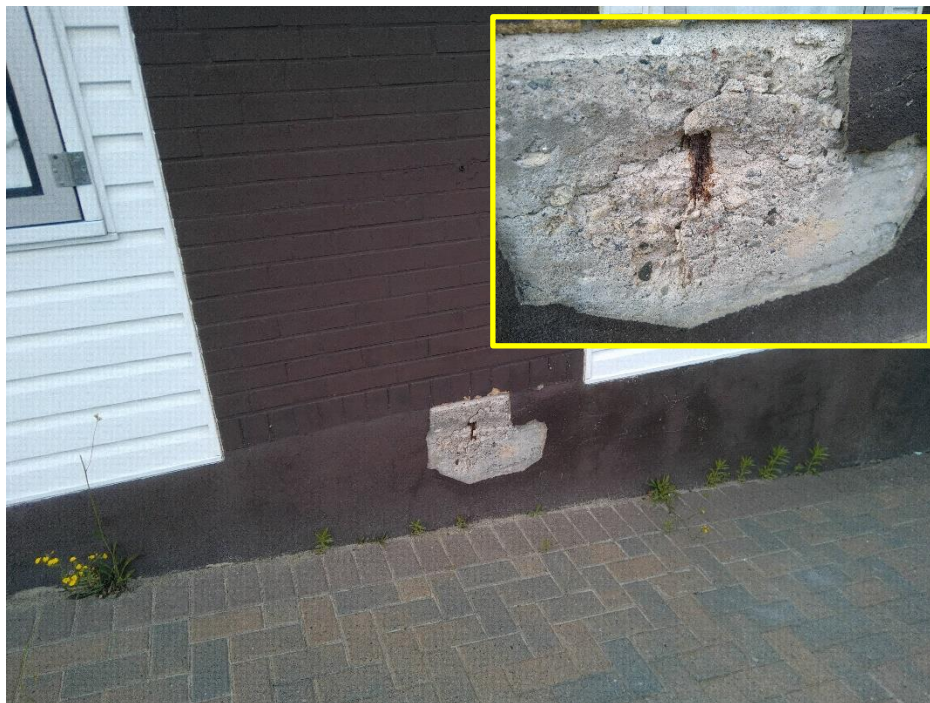
- Building envelope is generally in fair to poor condition, with evidence of chipped masonry units, spalled concrete (Figure 2), corroding reinforcement, damaged door frames and windows, missing steel siding and exposed strapping at parapet and wall edges.

Figure 2: Exposed and corroding reinforcing steel, south elevation.

The south elevation will require a variety of repairs to reinstate the building envelope. The entrance canopy which projects across the width of the south elevation retains water due to a failed waterproof membrane and clogged drains. Either the saturated (absorbent) layer of sheeting beneath the membrane, or the slight slope of the cantilevered Q Deck, is allowing water to enter the second-floor decking and cause corrosion.

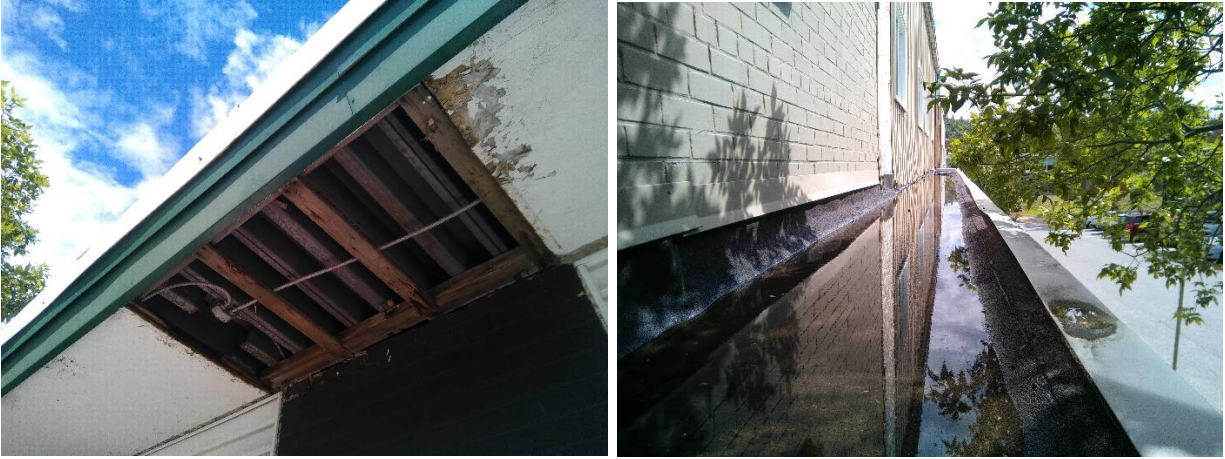
- A horizontal projection extends 36 inches to form an entrance canopy and runs the width of the building. It relies structurally on a cantilevered extension of steel floor decking, suspected to be Robertson Q-Deck (available during period of original construction). This projection had two inches of ponding water on top of the asphalt roll roofing layer at the time of inspection (Figure 3). A portion of OSB (Aspenite) panel comprising the soffit was removed for inspection. The soffit was decayed and coal tar pitch was noted above it. Tentest sheeting (possibly two layers) above the Q-Deck was soft and saturated.

Figure 3: Eave projection along south elevation. Note continuation of steel floor decking and water ponding issues.

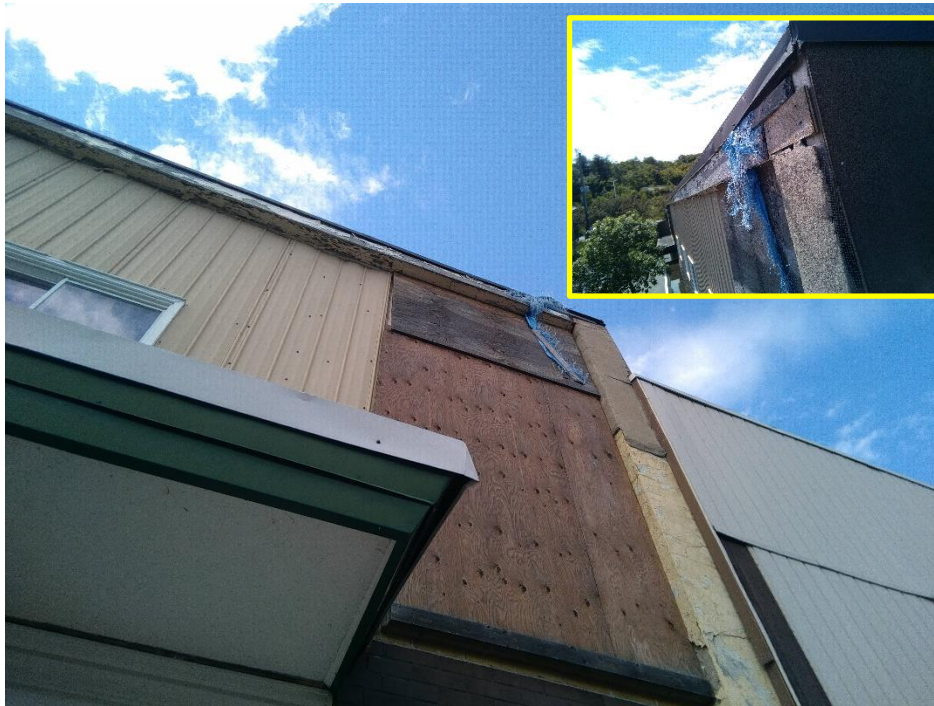
- The second floor exterior wall is light-framed (2x4) construction, clad in steel siding in fair condition, with newer vinyl-framed windows. Areas of plywood sheathing and wood strapping are exposed and weathered (Figure 4).

Figure 4: Upper east corner of south elevation, exposed sheathing and strapping at parapet.

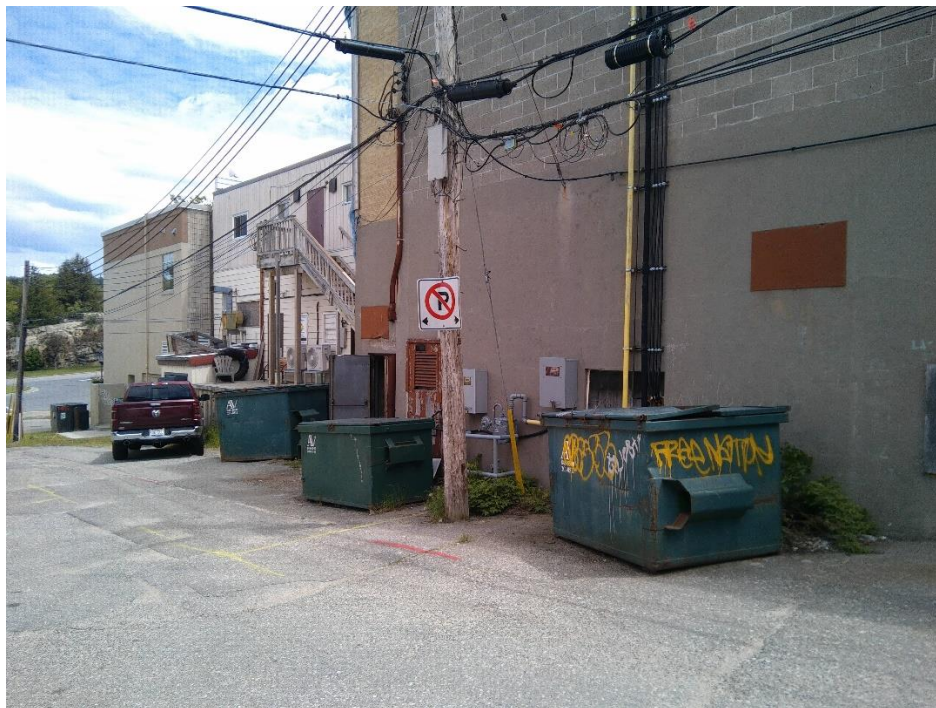
- Wall construction includes CMU and brick veneer atop cast-in-place, parged concrete walls. Masonry on the north elevation is in good condition, with some localized deterioration around roof drain spouts and door. (Figure 5, 6).
- Both sets of exterior double exits are original, heavy-gauge steel doors, frames and hardware that show deterioration befitting their age. Frames and hinges are corroded, and surrounding cementitious grout is cracked and spalled.

Figure 5: View of north elevation, east side.

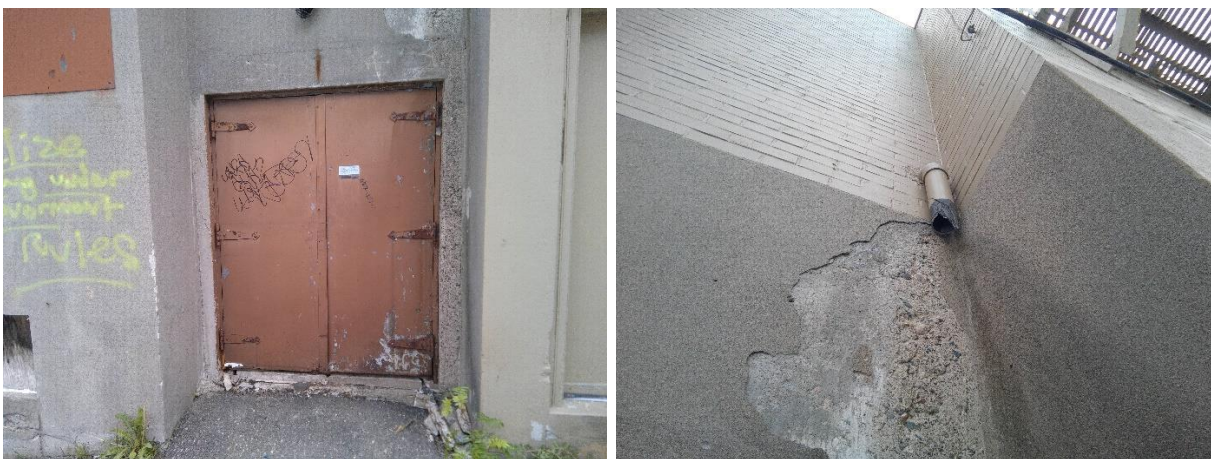
Figure 6: North elevation, deteriorated exit door and roof drain.

Masonry and concrete on the north elevation is generally in good condition but the shortened drain spout on the west side of the north wall is causing premature deterioration of the parging and may lead to accelerated deterioration of the concrete wall.

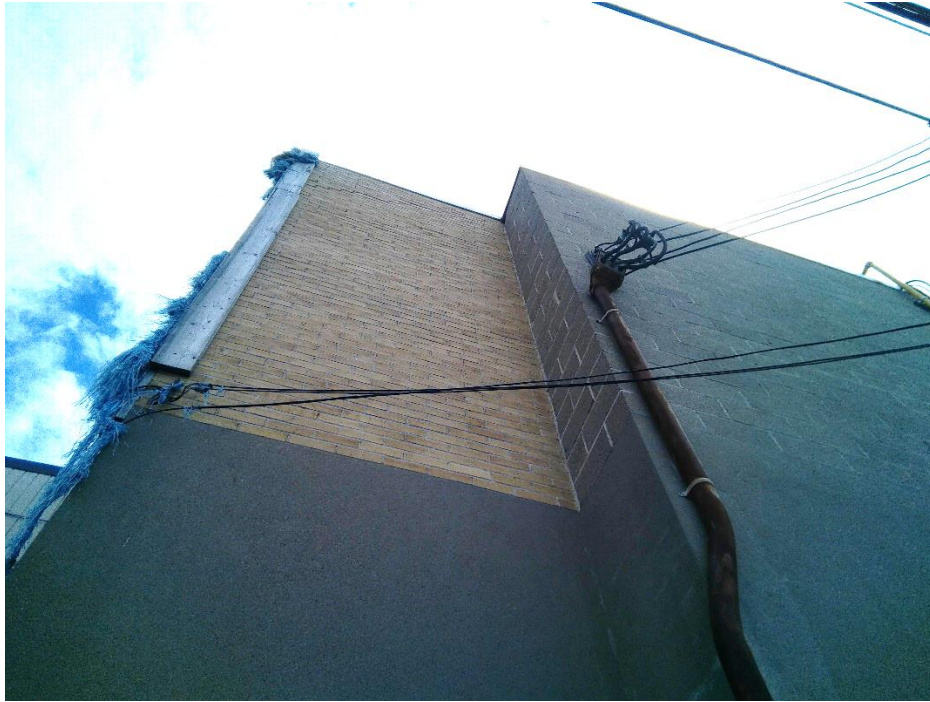
Figure 7: Masonry on north elevation of building, east side.

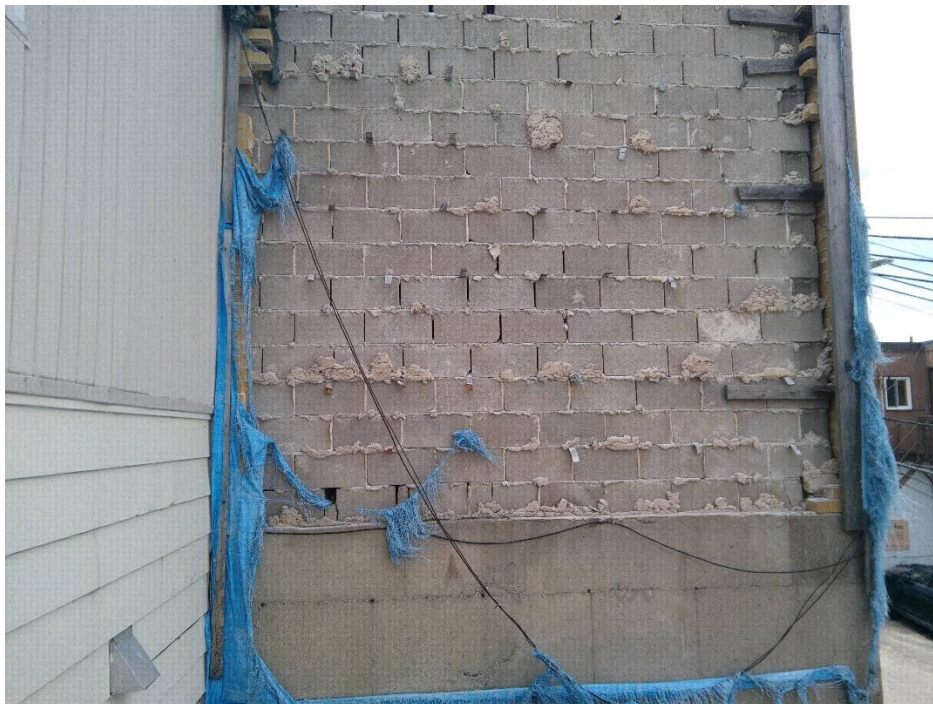
- The east elevation is mostly obscured by the commercial building to the east. However, these units do not share a common wall.
- A four-foot step and approximately 20 feet of exterior wall at the northeast corner of the building are exposed. This exposed masonry had been the subject of the City Order to Remedy of October 2016. Currently, the loadbearing CMU is open to the elements on the north part of the wall. The CMU wall presents several voids and reveals the steel baseplates and ends of the roof trusses. No corrosion was noted on the truss ends or baseplates at the time of inspection (Figure 8-12).

Figure 8: Exposed loadbearing masonry, east elevation, north side.

The exposed CMU wall at the northeast corner of the Theatre will lead to corrosion of primary roof framing and deterioration of the loadbearing wall if left unaddressed. Proper tie-in between a new wall covering, the brick veneer to the north, and the roof step cladding to the south, is essential. The status of the brick ties at the northeast corner of the building is not known and it should be inspected.

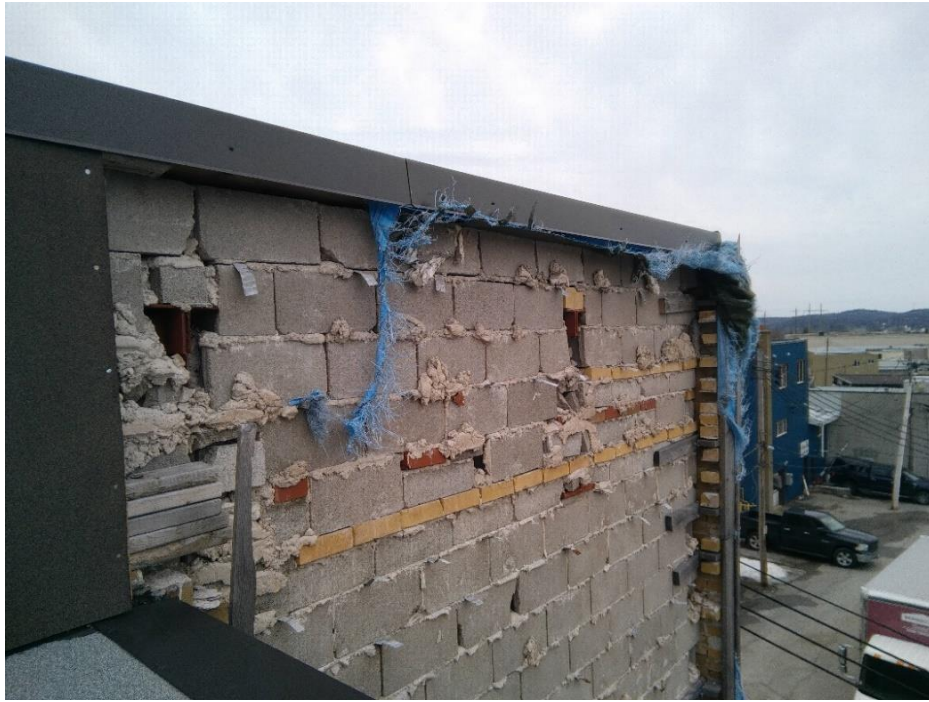
Figure 9: Exposed loadbearing masonry on northeast corner.

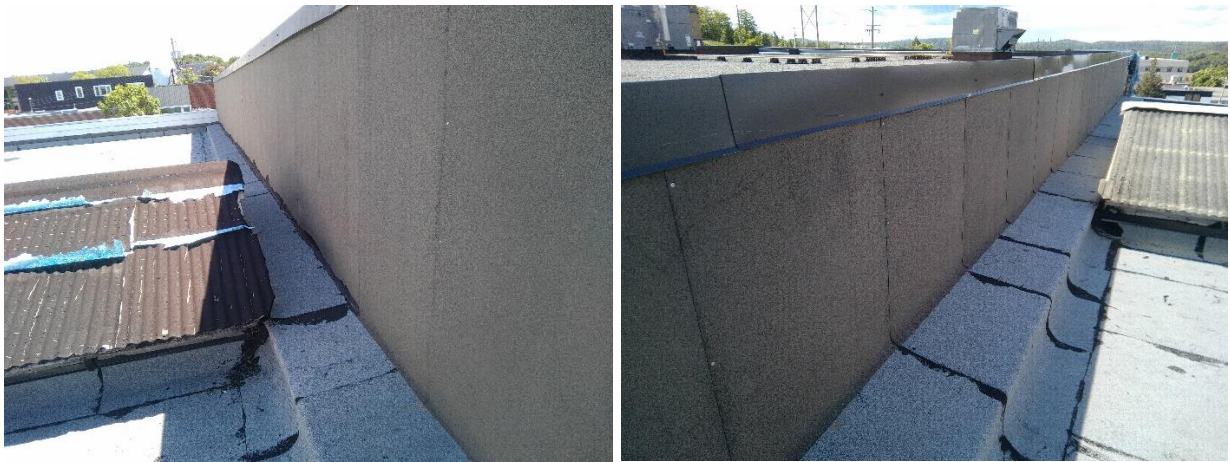
Figure 10: Roof step between theatre and neighboring unit to the east.

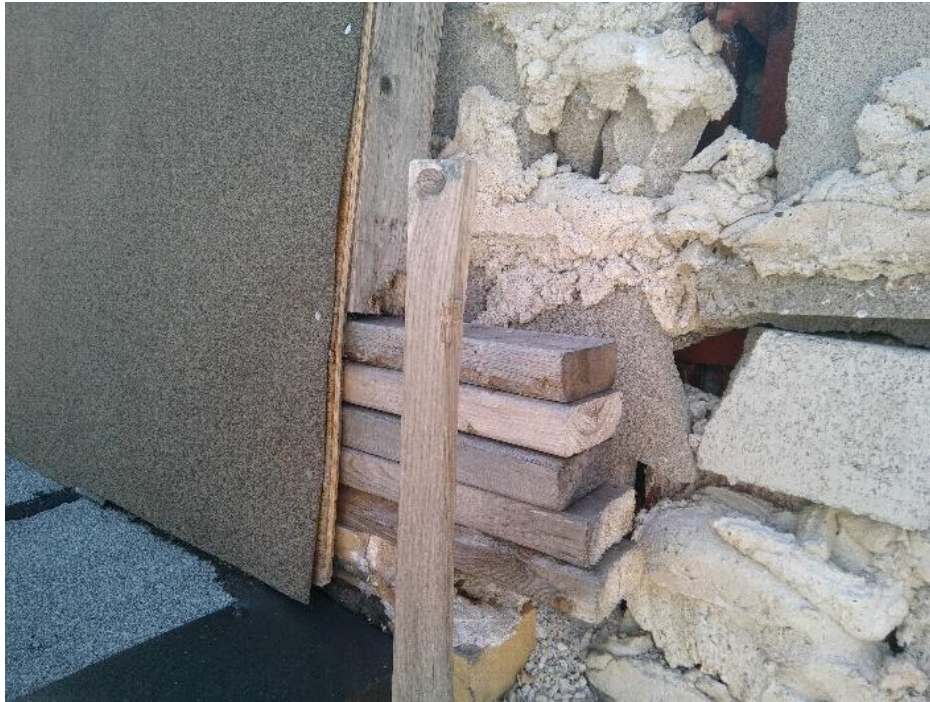
- Evidence of the original brick veneer remains at the northeast corner, and brick ties were observed. The remainder of the step is strapped with 2x4, sheathed with plywood and covered with roll roofing. The covering was sound, firmly affixed to the wall and in good condition during the time of inspection. However, its north edge was unfinished and open to the elements (Figure 11).

Figure 11: Transition from asphalt roll roofing-covered plywood skirt to exposed masonry wall, east elevation.

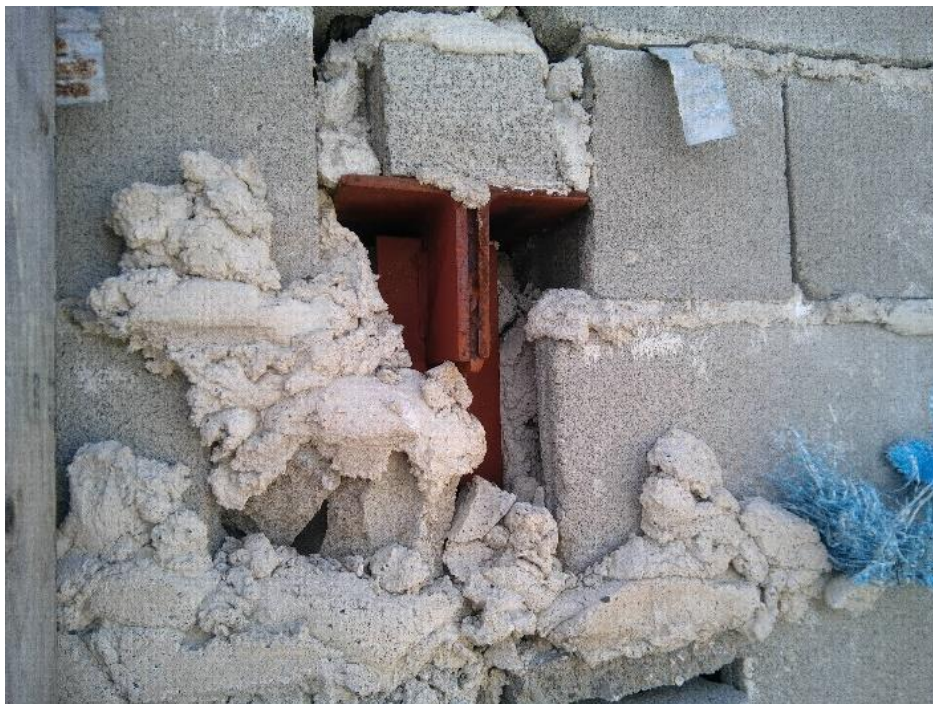
Figure 12: Exposed truss top chord, northeast corner.

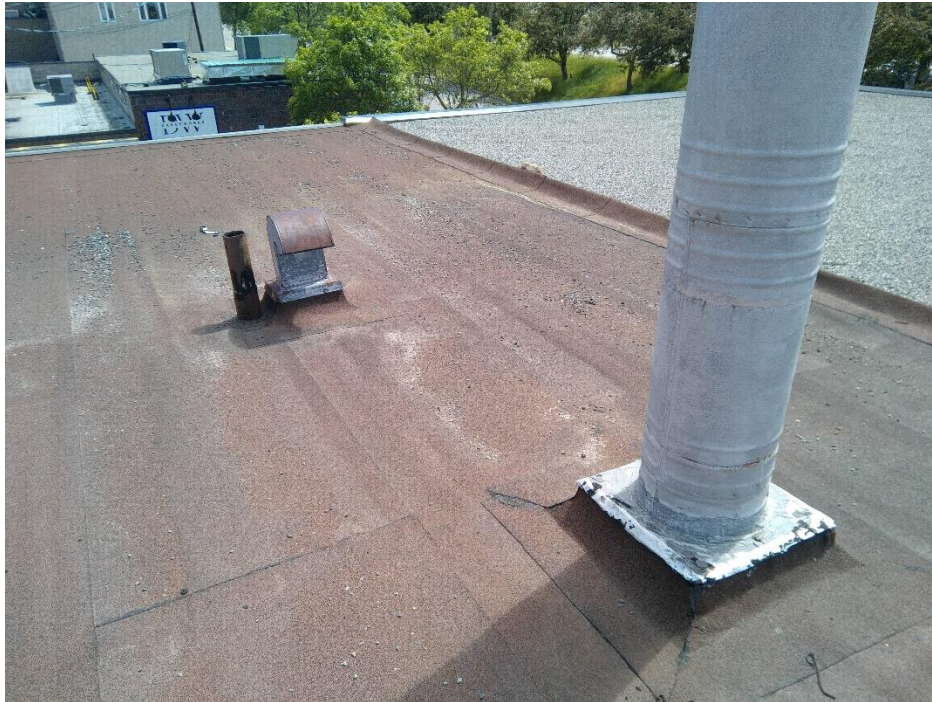
Figure 13: Older (unused) roof projections, south end.

The partial roof replacement occurred sometime between 2012 and 2013. While the modified bitumen roof on the south portion (approximately 3,200 square feet) is twenty years older, it is performing well. Flashings and seals around all unused vents and projections should be inspected and repaired by a roofing contractor.

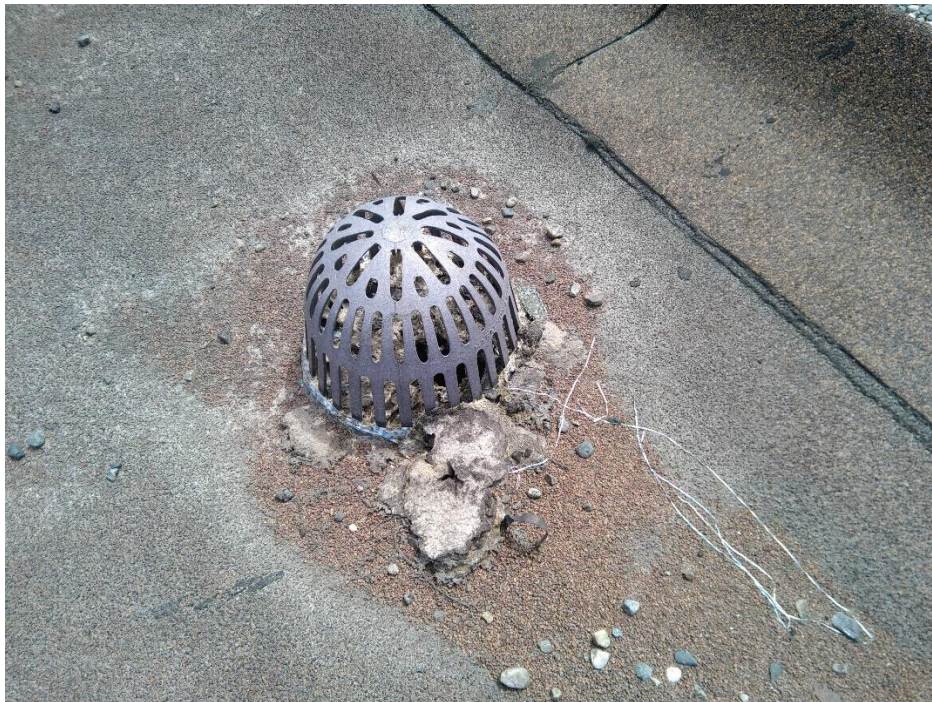
observed. Roof drain strainers appear to match the date of re-roofing and are in good condition. (Figure 14)

Figure 14: Older roof drain and strainer, south end of building.

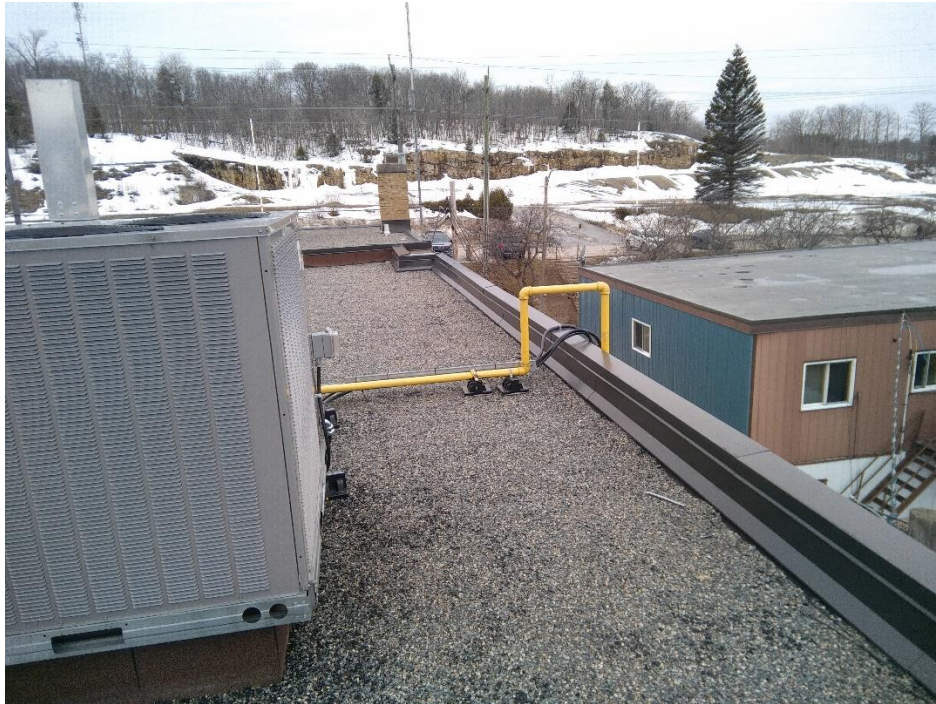
- A built-up roof with gravel ballast covers the north portion of the building. Date of installation is believed to be between 2012-13. No relevant documentation was available during file review. Newer rooftop units (RTU) were installed in December 2020 (Figure 15). Parapets, flashings, curbs and roof surface are all in good condition, with no evidence of ponding.

Figure 15: North roof parapet and newer RTU, April 2022.

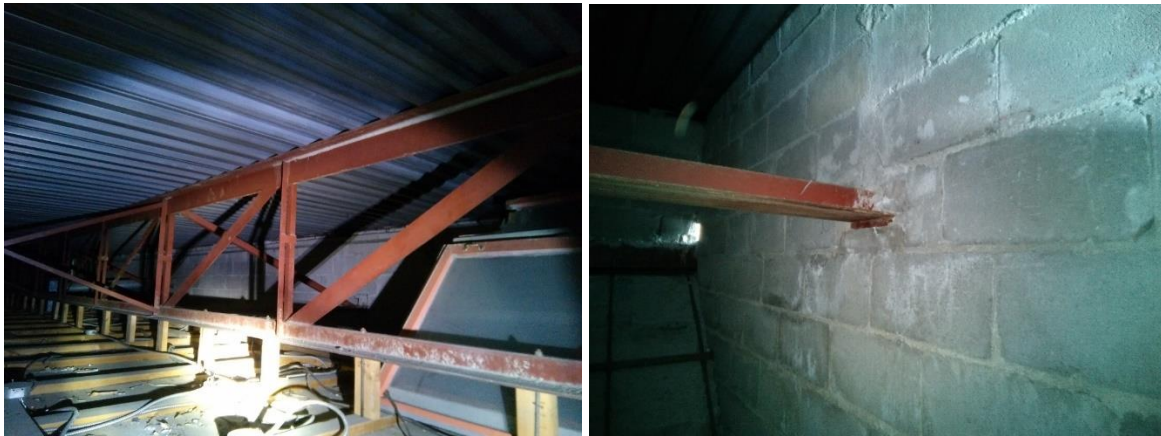
- Roof trusses are either primed or painted, bottom-chord bearing on 5/8-inch plates laid in the east and west CMU walls. Cross-bracing is present on all truss quarter-spans. The roof trusses are in good condition, with no signs of corrosion or distress (Figure 16-18).

Figure 16: Roof trusses, roof deck and termination in masonry wall, south end of building.

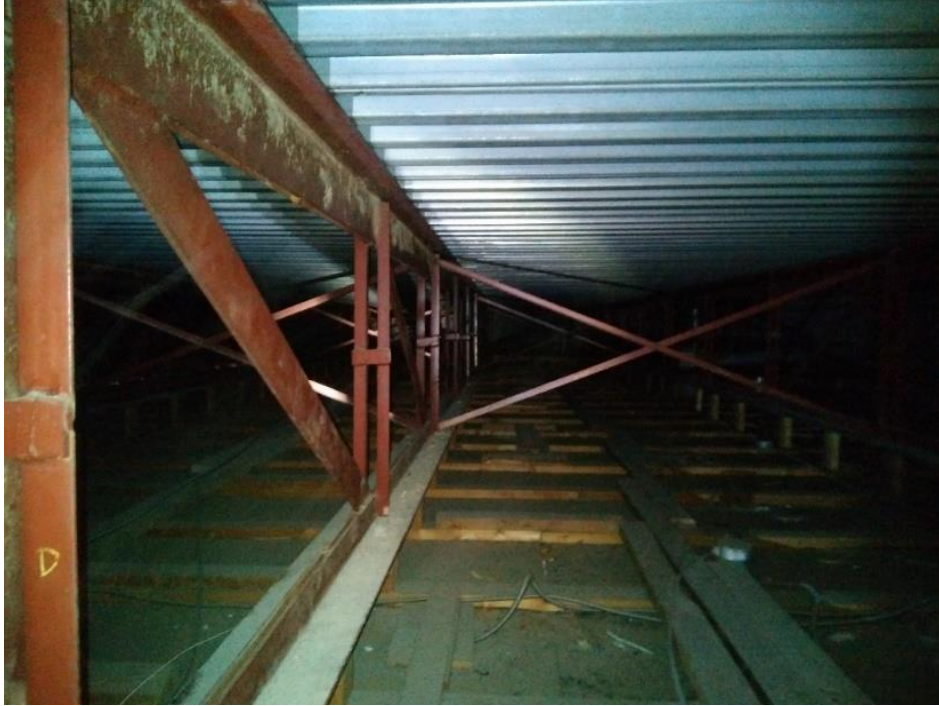
Figure 17: Roof truss and bracing, south end of building.

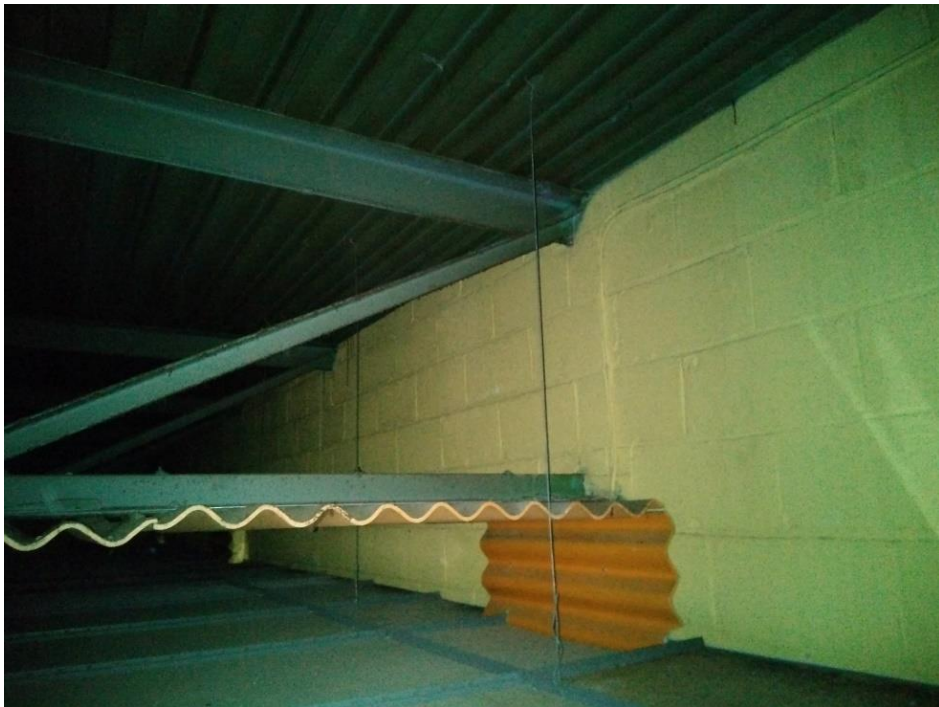
Figure 18: Truss terminating at loadbearing masonry wall, Theatre 2 east wall.

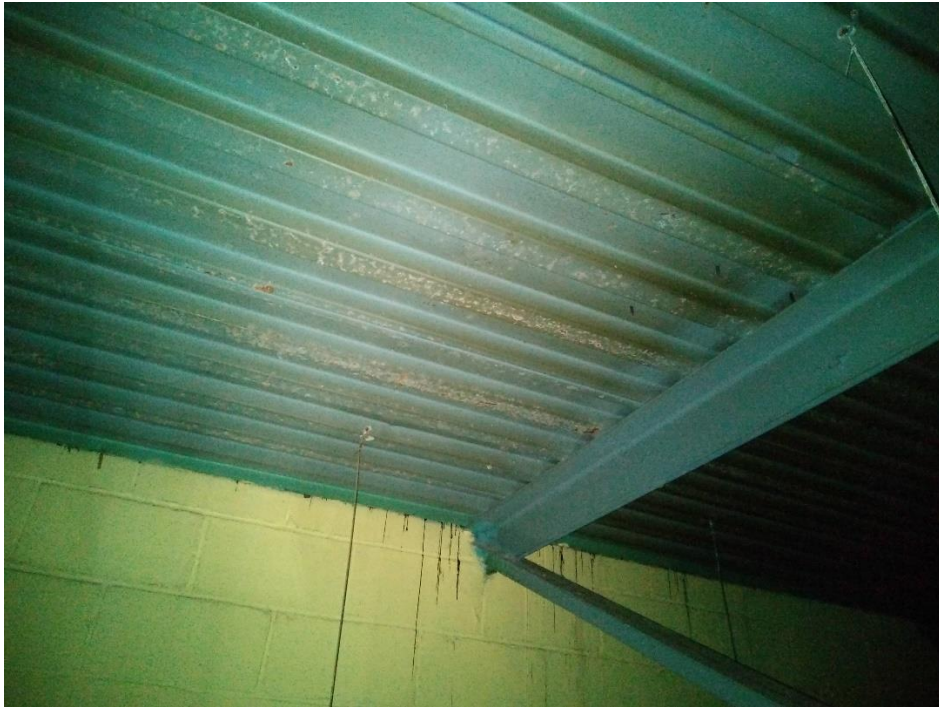
- Roof deck in the east theatre (Theatre 2) was also visually inspected and sounded from the platform. A perforation due to corrosion was visible from ground level in the northwest corner of the seating area. An area covering approximately 750 square feet displayed light discolouration and some pitting of the painted deck underside. Upon further investigation, localized sections of roof deck were completely corroded (Figure 20).

Figure 19: 1-1/2 inch roof deck in Theatre 2, north end.

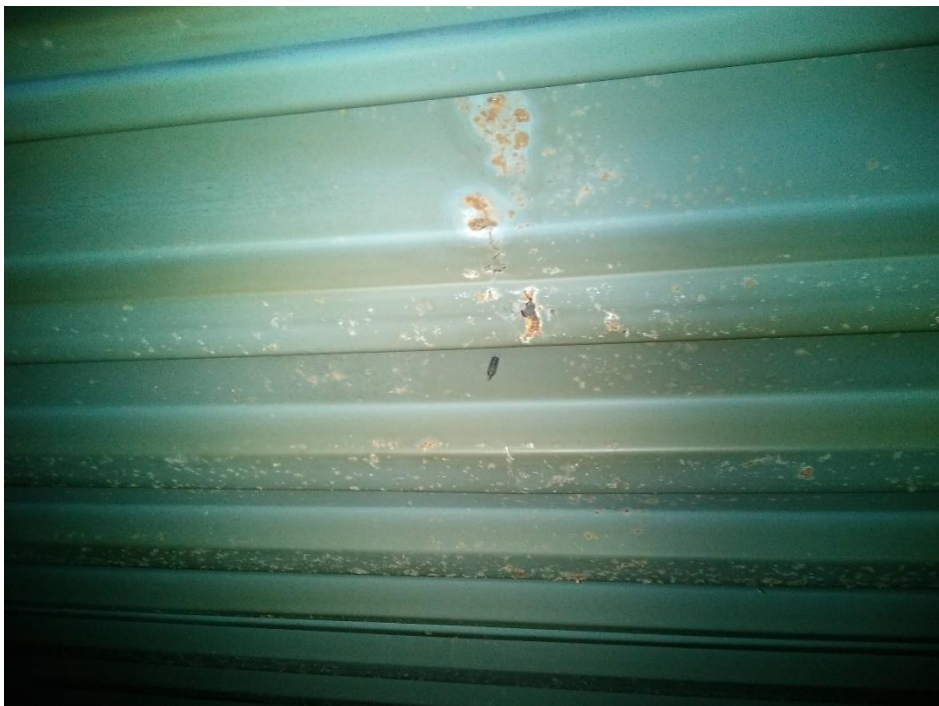
Figure 20: Close-up of corroded and perforated roof deck, Theatre 2.

The suspected cause of roof deck corrosion may be linked to previous roof leaks, saturated roof sheeting, trapped water, lack of building climate control, or a combination of these factors. Since it is unknown whether the corroded deck is due to current roof leaks or from leakage that occurred prior to the latest reroofing, we recommend further investigation of the roofing in this area. The extent of corroded roof deck is not visually apparent from the underside at ground level. It should be mapped out accurately by removing all suspended ceiling tiles and completing a thorough survey of the deck with an ultrasonic thickness gauge. This will require the removal of most fixed seating in the theatres, and the use of an elevated work platform. Depending on the extent and severity of corrosion, partial roof deck replacement may be necessary.

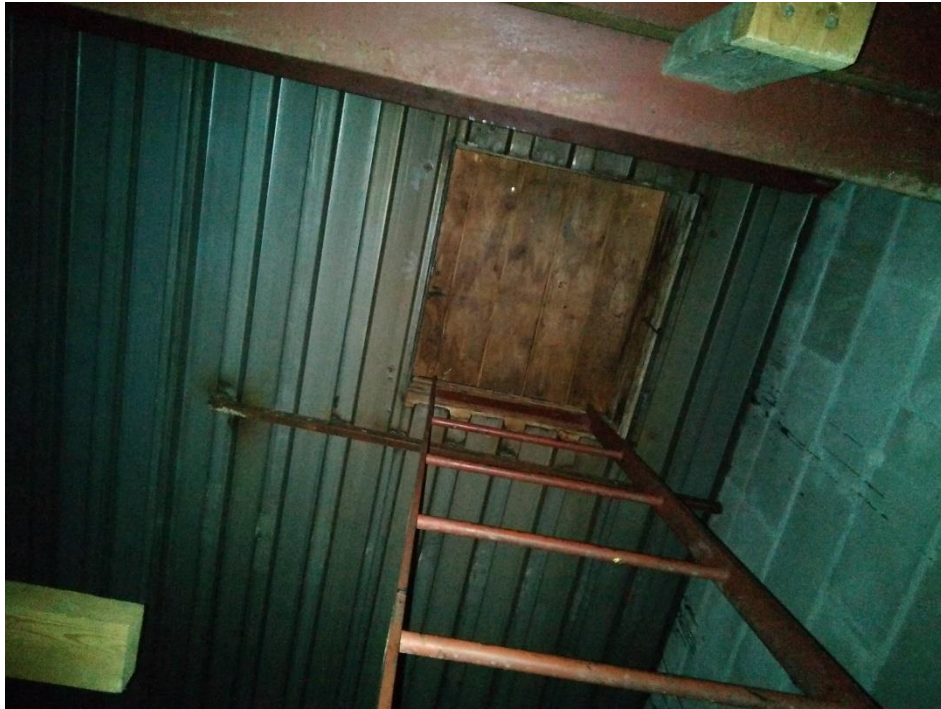
- The roof access ladder and hatch are located near the southeast corner of the building (Figure 21). The welded steel ladder is in good condition, but lag screw connections to the hatch frame are loose. The hatch is of robust wood-framed construction with galvanized sheet metal covering. Due to some bent sheet metal and a lack of interior grab handles, it fits poorly and is difficult to close.

Figure 21: Roof access hatch, southeast corner.

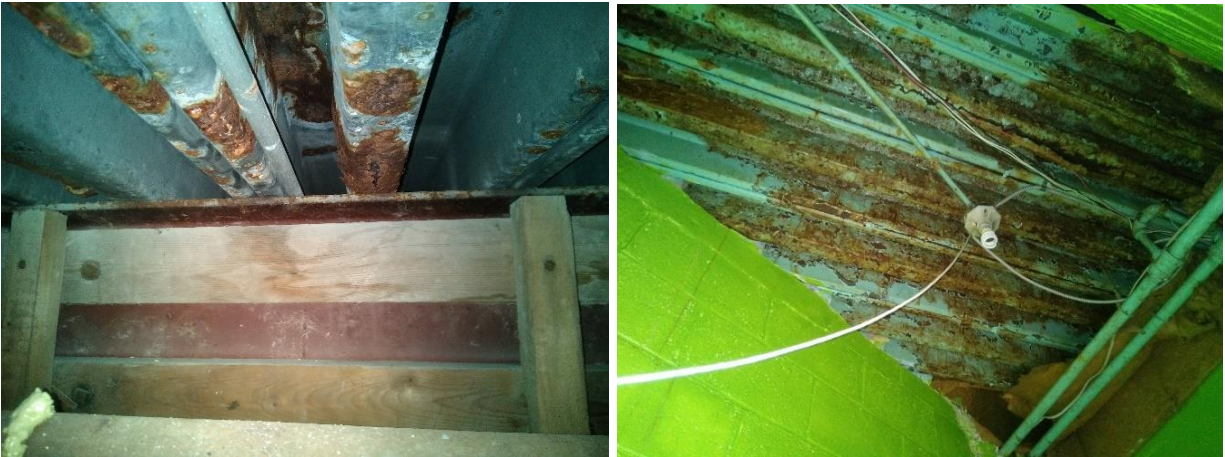
- Q-Deck underside is painted in all accessible locations (washrooms, vestibule, ticket booth and stairwells). Deck is heavy gauge (0.059-in) steel but badly corroded in some areas that are closest to the south exterior wall (Figure 22).

Figure 22: Images of Q-Deck corrosion as a result of ponding and leaks through projection.

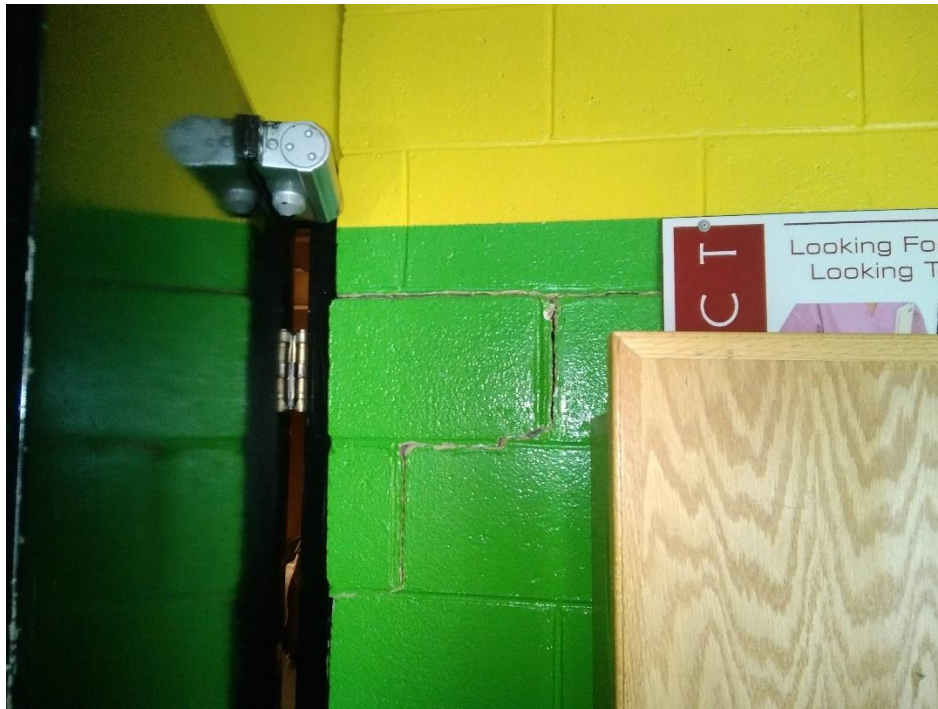
- Cracks in mortar, loose blocks and shifted blocks were noted in the CMU non-loadbearing partition walls behind the snack bar counter (Figure 23). These walls are identified for removal in the renovation plan.

Figure 23: Cracks and loose CMU noted in lobby partition walls.

Cracked and displaced non-loadbearing CMU partition walls to the north of the lobby are earmarked for removal during the renovation and are not a concern. After removal, the slab will be inspected in this area and repair details will be provided if necessary.

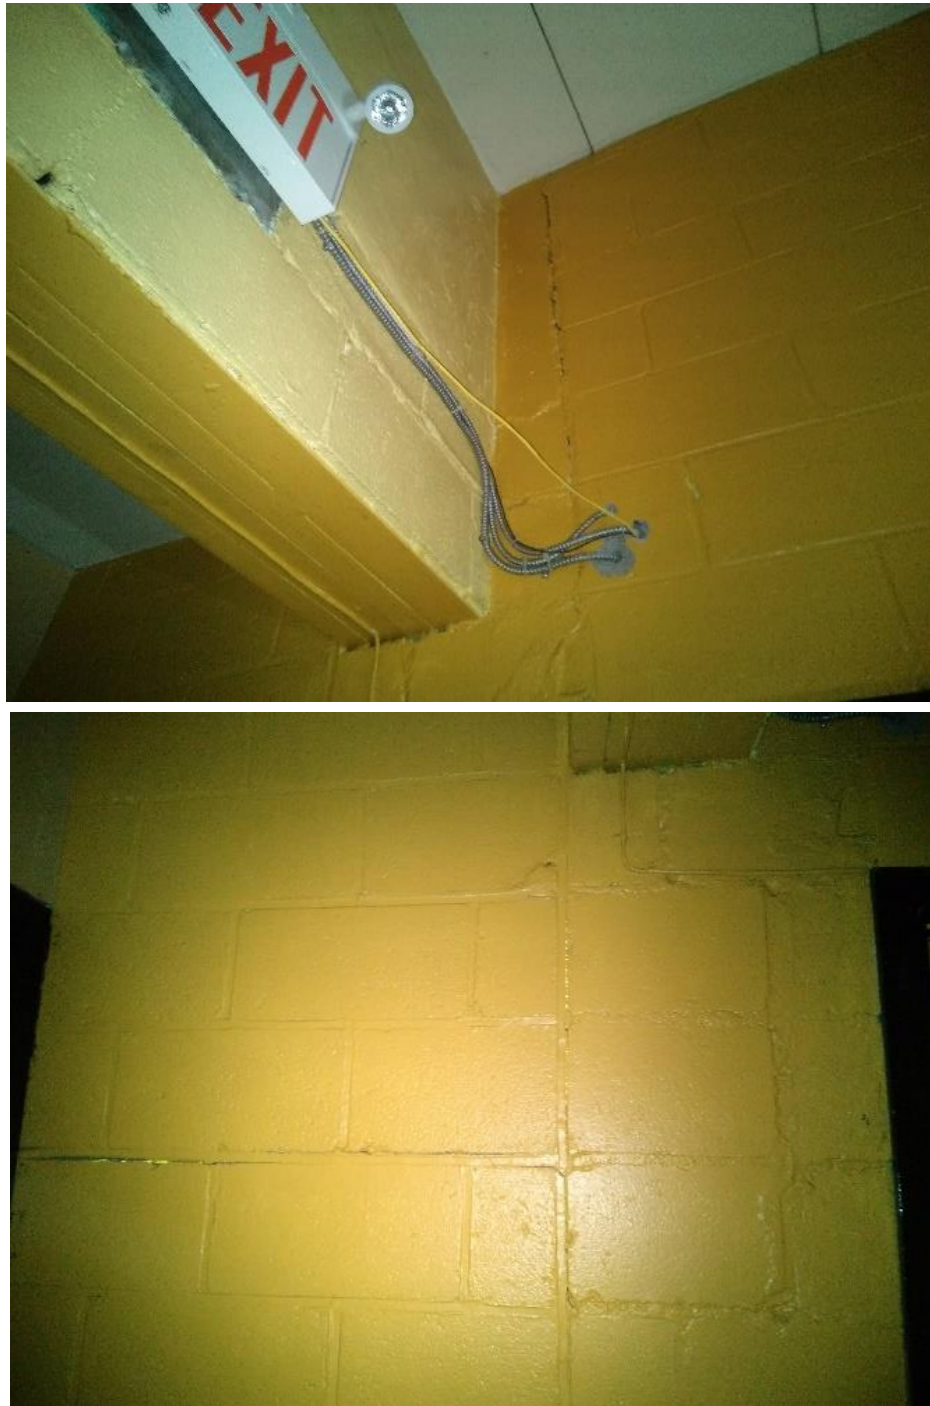
- A portion of the projection room's north wall was assessed to be loadbearing CMU. It is in good condition.
- Vertical cracks were noted adjacent to the lintel spanning the Theatre 2 entrance hallway. These cracks propagated through a joint between loadbearing units and the adjacent partition wall (Figure 24).

Figure 24: Images of lintel across loadbearing interior wall. Note cracks in mortar joints in adjacent partition walls.

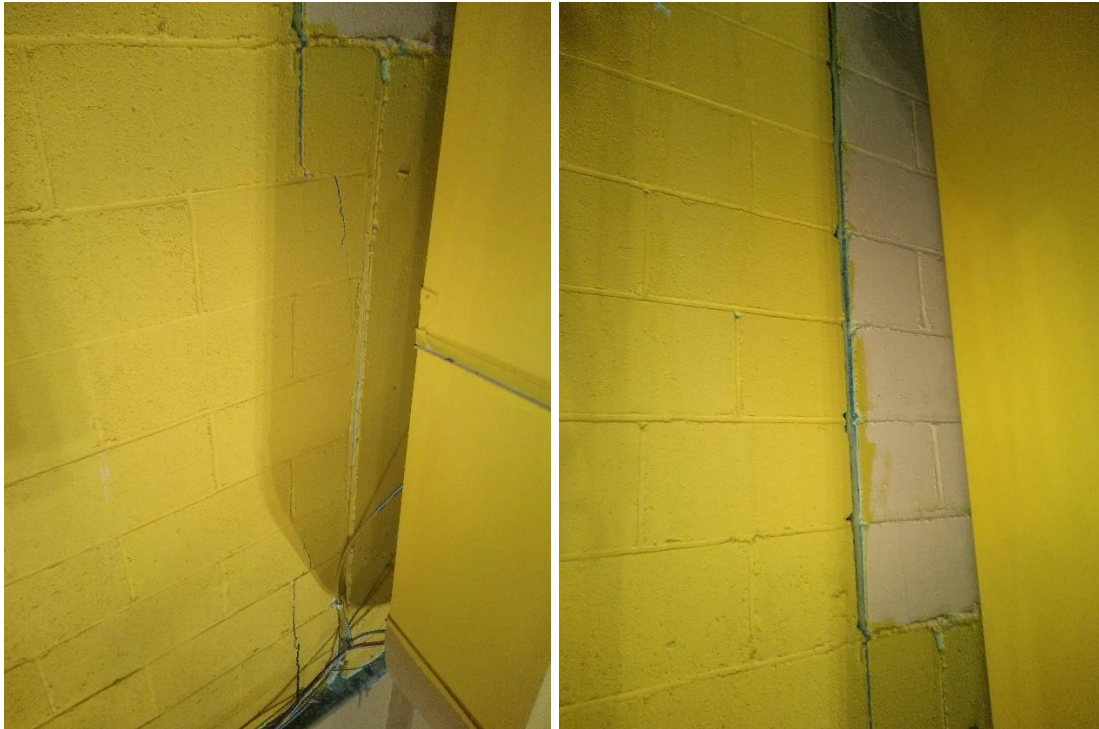
Figure 25: Control joint and vertical cracking observed in Theatre 2 east wall.

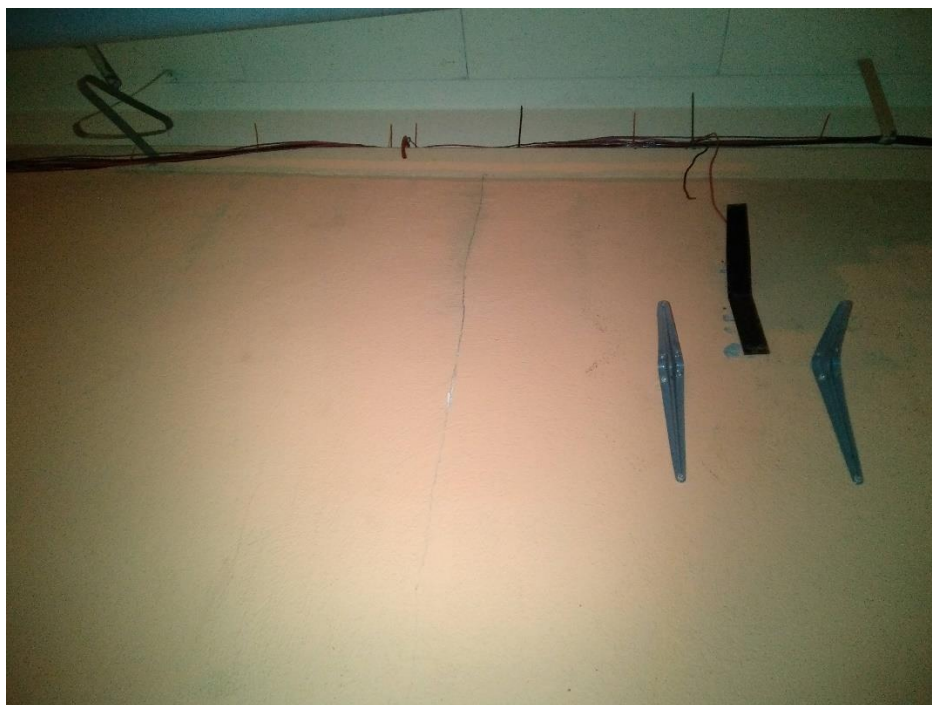
Figure 26: Continuous crack in Theatre 1 west wall.

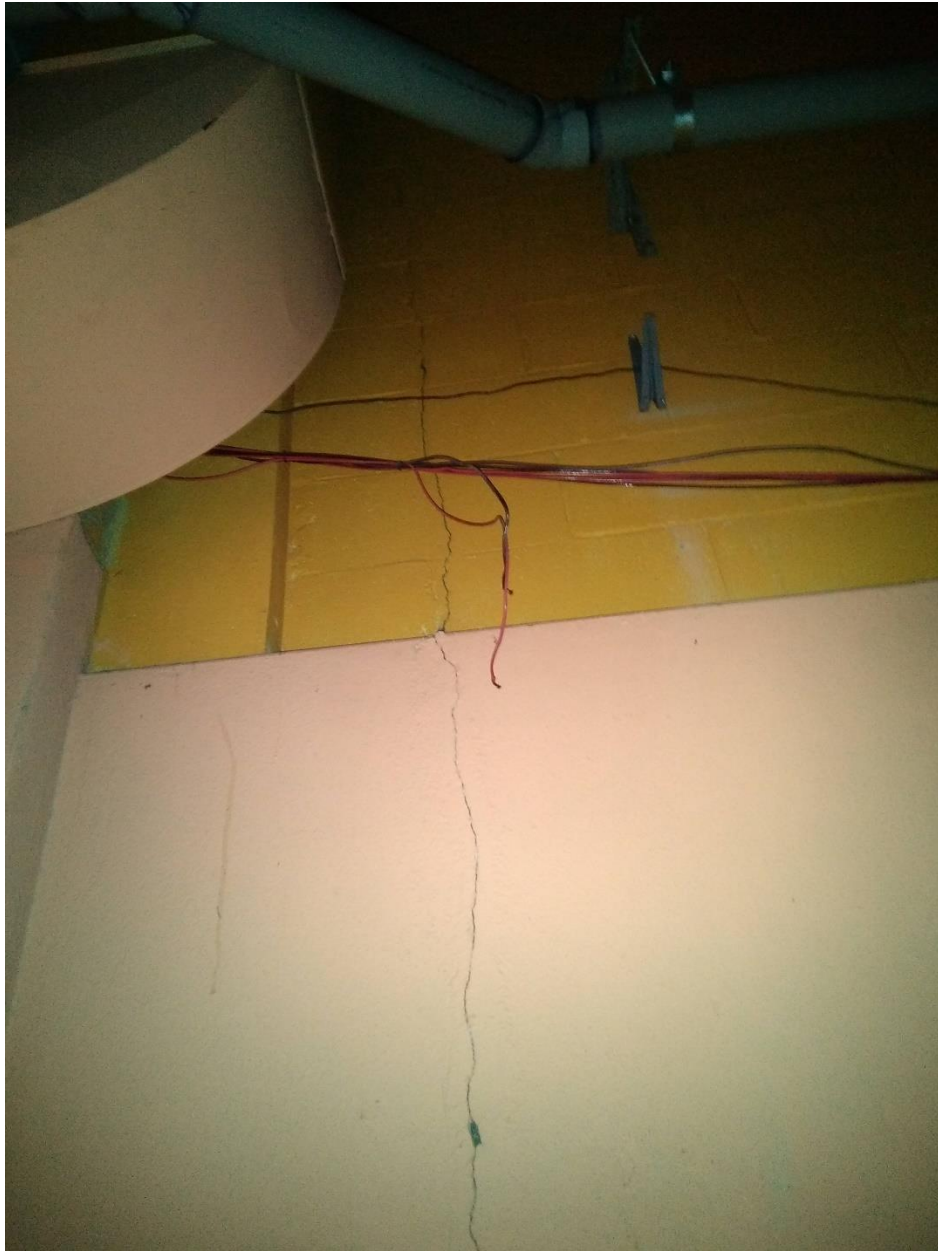
- The dividing wall between stages consists of a double 5/8-inch drywall and ½-inch fiberglass noise-stop board on either side of a 6-inch metal stud wall, as per drawings. It is in good condition.
- A vertical joint was noted on the upper east wall of Theatre 2, forward of the balcony. 3/8-inch plywood was observed in the joint and no gaps were observed. This joint did not run the entire height of the wall, but terminated above eight courses of CMU and the cast concrete portion of the wall (Figure 25). Some CMU to the north of the joint were cracked vertically.
- A continuous, shallow vertical crack was noted in the west wall of Theatre 1, forward of the balcony. This crack propagated through both the base concrete and upper masonry unit walls (Figure 27).

Figure 27: Continuous crack through cast-in-place wall and CMUs, Theatre 1 west wall.

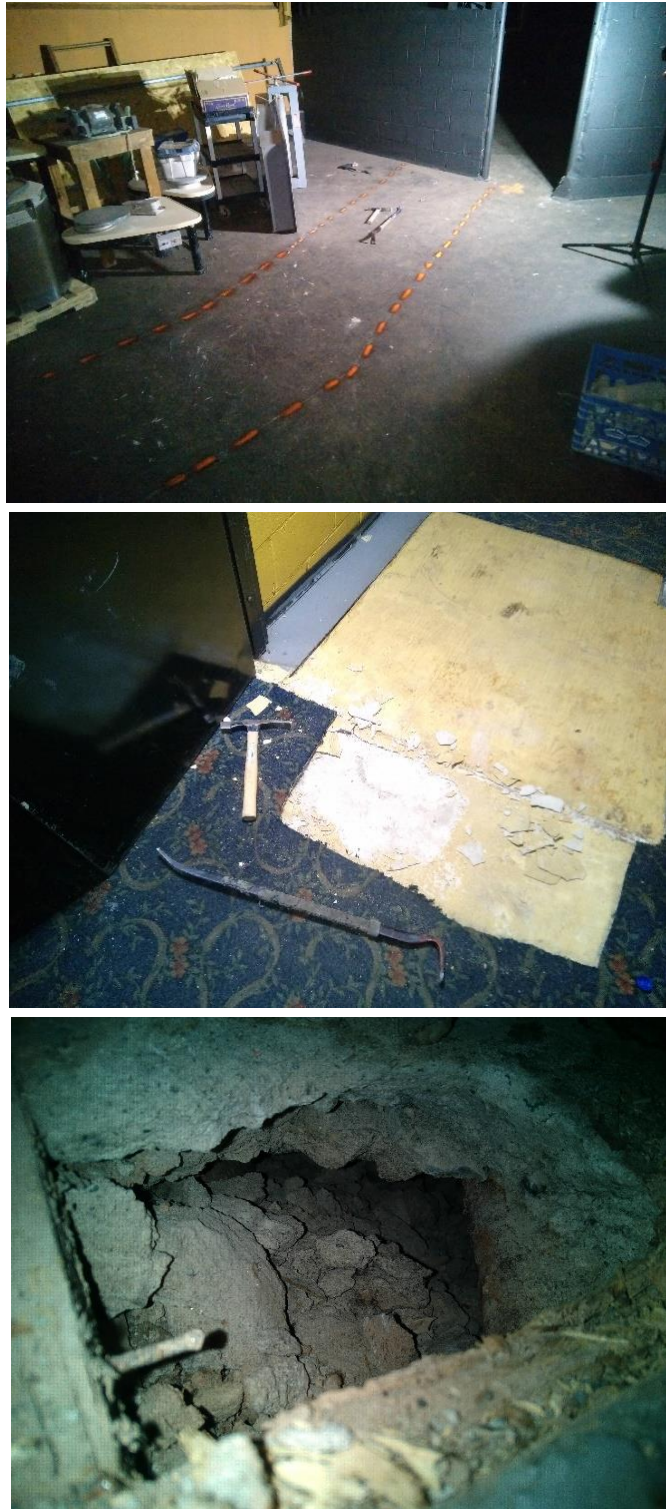
- Visible components of the foundation consist of a slab on grade of unknown thickness. Drawing review (1993) and investigation of penetrations in the slab suggest a nominal thickness of six inches. Reinforcement type and layout is unknown.
- Floor slabs are in generally good condition, but some areas are poorly finished (northwest exit stair) or undulating. A 32-inch wide, shallow services trench is present in both theatres (Figure 28). This trench was further investigated in Theatre 2, where it extended to the low point line forward of the stage. The status of conduits and piping observed inside these trenches is unknown.

Figure 28: Images of utilities trench investigation, Theatre 2.
