MECHANICAL EQUIPMENT ASSESSMENT REPORT

Ruben Yli-Juuti Aquatic Centre

301 MISSISSAUGA AVE., ELLIOT LAKE, ON

Submitted to:	Don Crain
Project No.:	20M74
Report By:	Tim Janzen, P.Eng.
Date:	December 2020
Revision:	0

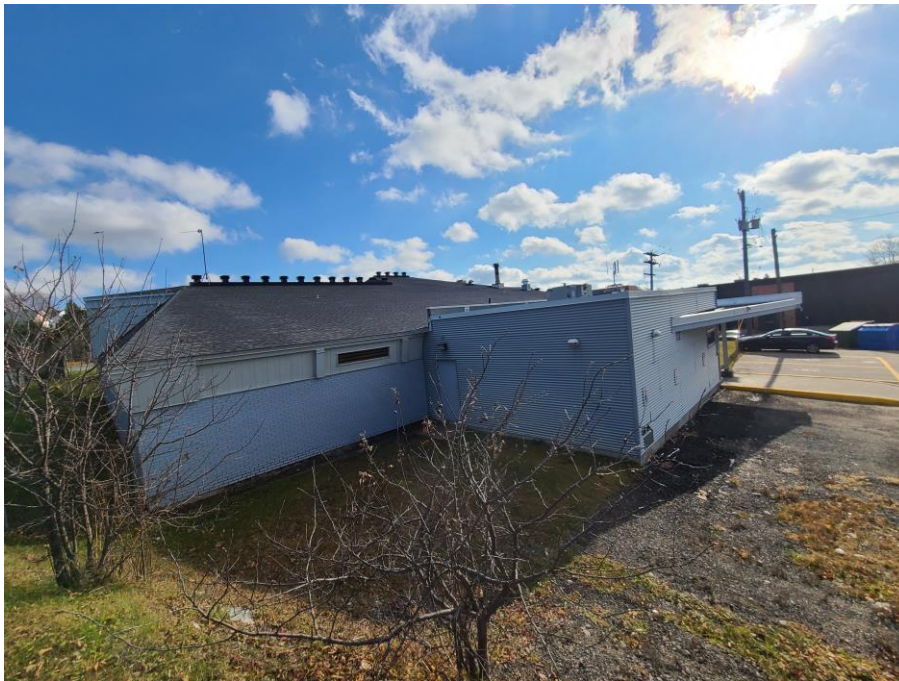
In 1998, alterations to the facility included the addition of a front entrance and an exercise room. The added front entrance and exercise room are both serviced by a dedicated Trane Rooftop Unit (RTU) Model YCC030F1M0BE. The RTU provides heating, cooling, and ventilation air to the space. Although the RTU is of adequate design for the space, the unit has surpassed its life expectancy of 15-20 years. Continued use beyond normal life expectancy is possible, but will most likely result in higher costs for repairs on vital components such as heat exchanger and compressors.

Figure 2.1.1: Trane RTU and Fitness Area

The existing Trane RTU is installed onto a 6" tall curb. Typically, for installations of rooftop equipment in Northern Ontario, a taller curb is recommended. Installing equipment on a 18-24" tall curb can mitigate leaks and other issues caused by snow cover.

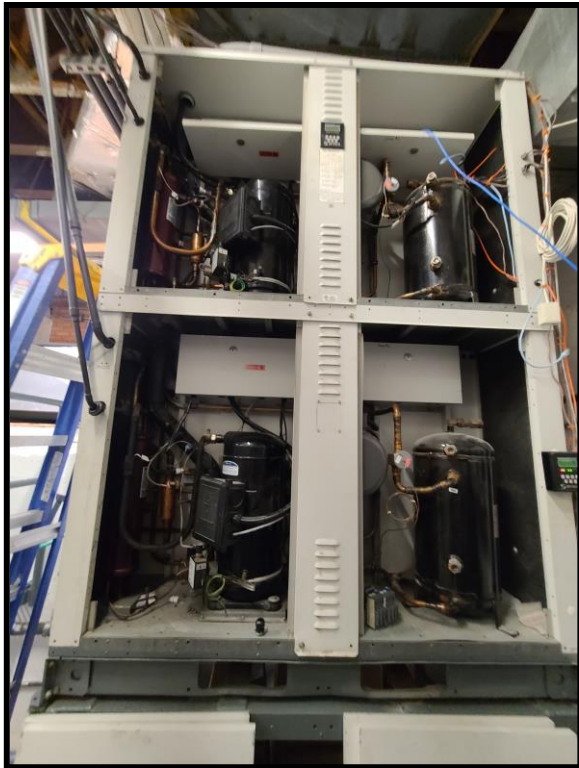
Fig. 2.2.1: Compressors inside Seresco Unit

Although it is common practice to install HVAC equipment indoors in dedicated mechanical rooms; it is not recommended with a pool environment in close proximity. The mechanical room in which both the Seresco and Venmar units are installed inside shares common air with the pool. In addition to the extreme humidity levels (relative to outside air) in the pool's atmospheric air, it also contains corrosive particles from the chemicals used to condition the water. This environment severely shortens the usable lifespan the equipment and other various components.

Presently, one of the two compressors in the Seresco unit has failed as a result. Most of the copper piping has corroded and is on the verge of failure beyond repair. Although some of the

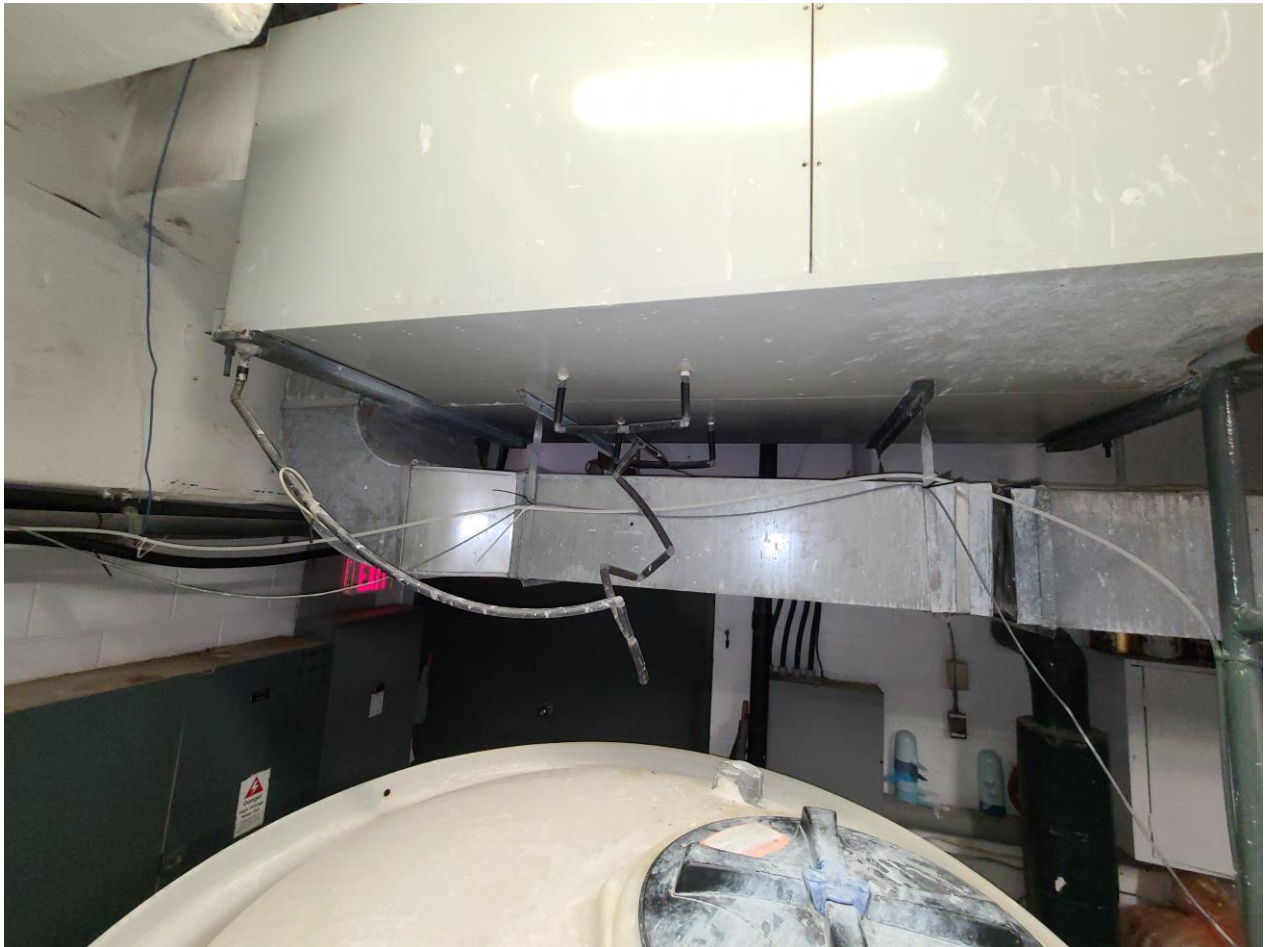
Fig. 2.2.2: Venmar HRV

The Venmar unit is very simple in comparison to the Seresco unit, however, it as well has significantly deteriorated over time and will be difficult to maintain or repair moving forward. Although the fan in the unit was replaced recently, the bearings and control board are still in need of replacement. The ductwork and drains from the unit have also rusted out and failed, temporary setups are currently in place due to this. In an effort to provide dilution to reduce humidity and corrosion, staff have made a 'makeshift' hole in the ductwork (Figure 2.2.5) to provide some fresh outside air into the mechanical room.

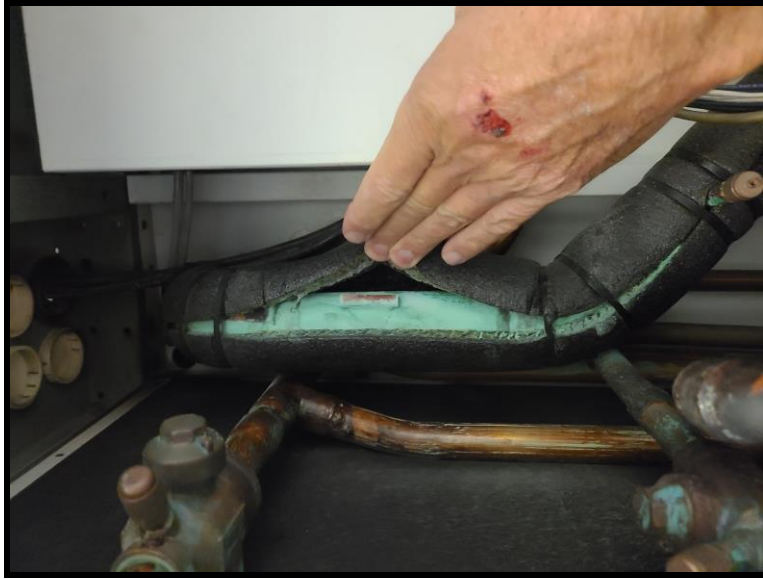
piping has been coated with an aftermarket paint in effort to extend its life, this may only be a temporarily fix.

Fig. 2.2.3: Example of Corroded piping in Seresco Unit

As seen in Figure 2.2.3 above, the corrosion issue on the Seresco unit is severe and in need of attention. If holes develop in the piping, repair may not be possible without replacing the entire coil and its associated piping.

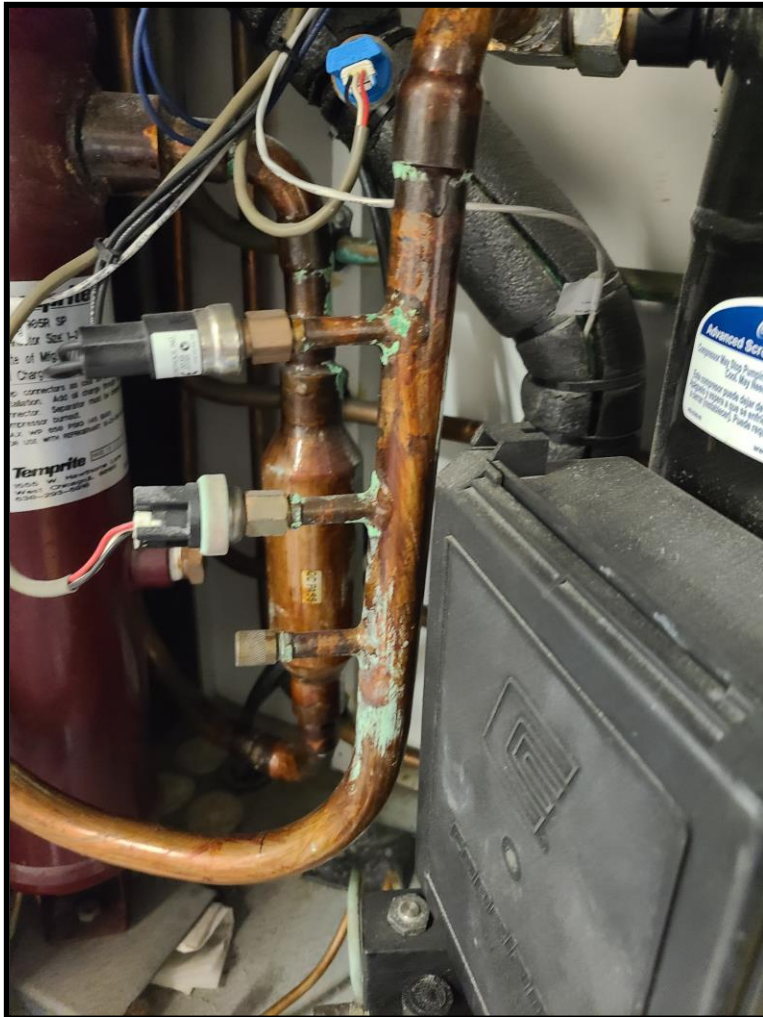
In addition to the corrosion issue on the piping, both the control and power wiring connections on the unit are corroding, shown below in Figure 2.2.4. The corrosion on the wiring is currently causing issues and will continue to cause problems with reliability in the future.

Fig. 2.2.4: More corroded piping inside unit

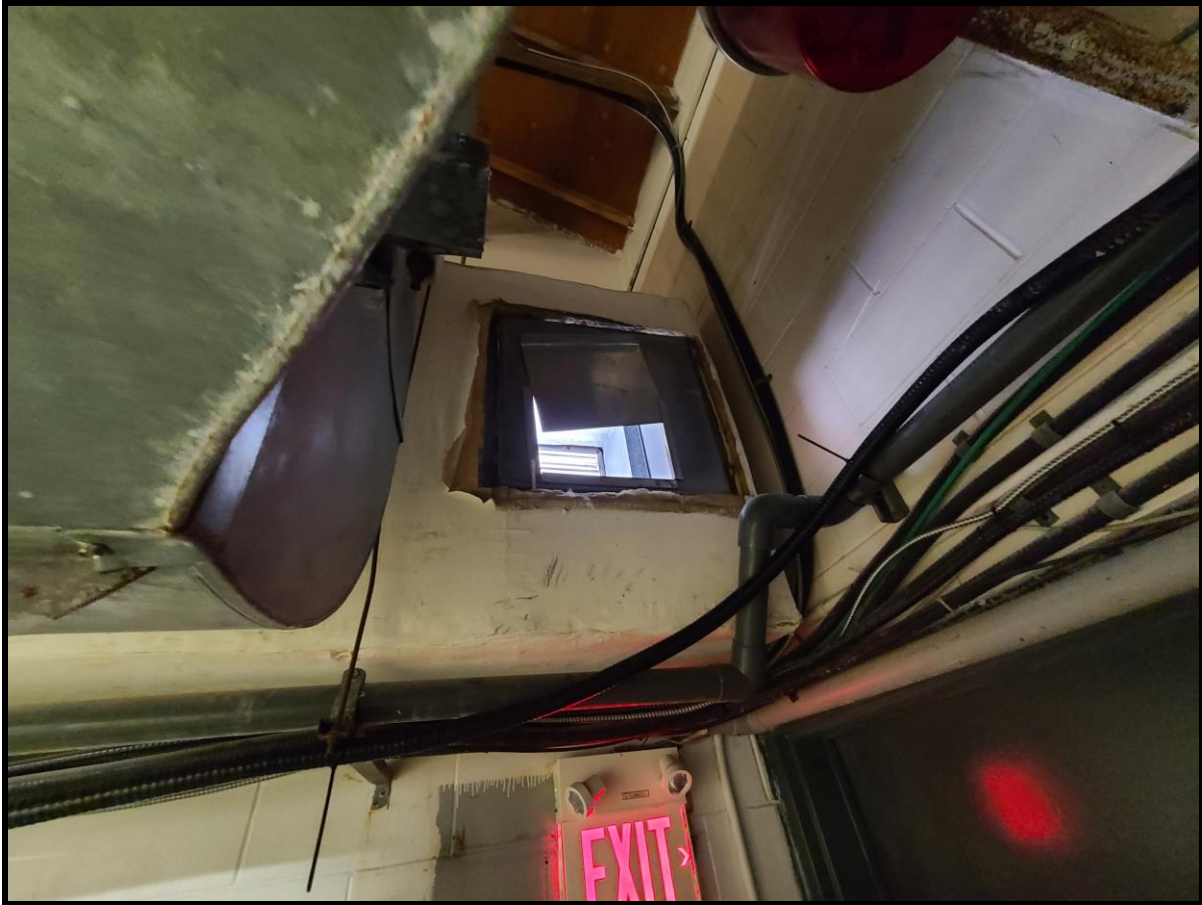
Fig. 2.2.5: Temporary opening in ductwork

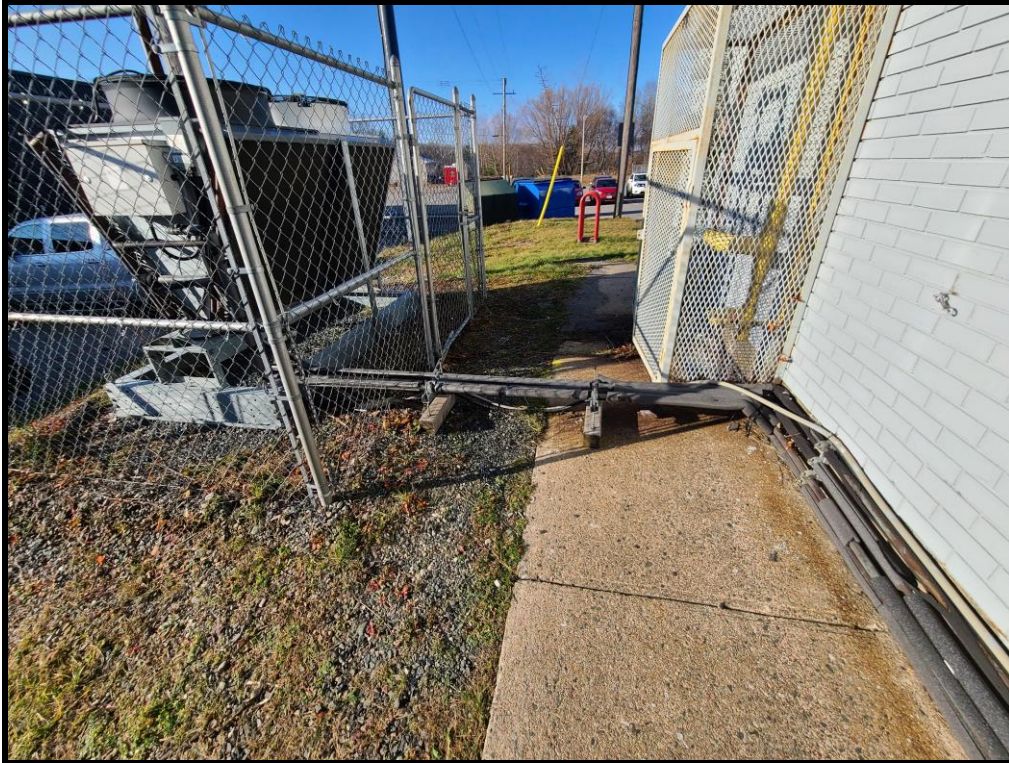
While most of the corrosion issues exist indoors, the exterior refrigerant piping and condenser are also deteriorating. The exterior refrigerant piping is not properly protected and has consequently deteriorated to the point where it needs to be replaced and properly insulated.

Fig. 2.2.6: Seresco Cooling Units and Piping

The condenser unit contains multiple leaks that require repairs, although, repair may not be possible. The coils on the condenser may need to be replaced to keep the units running.

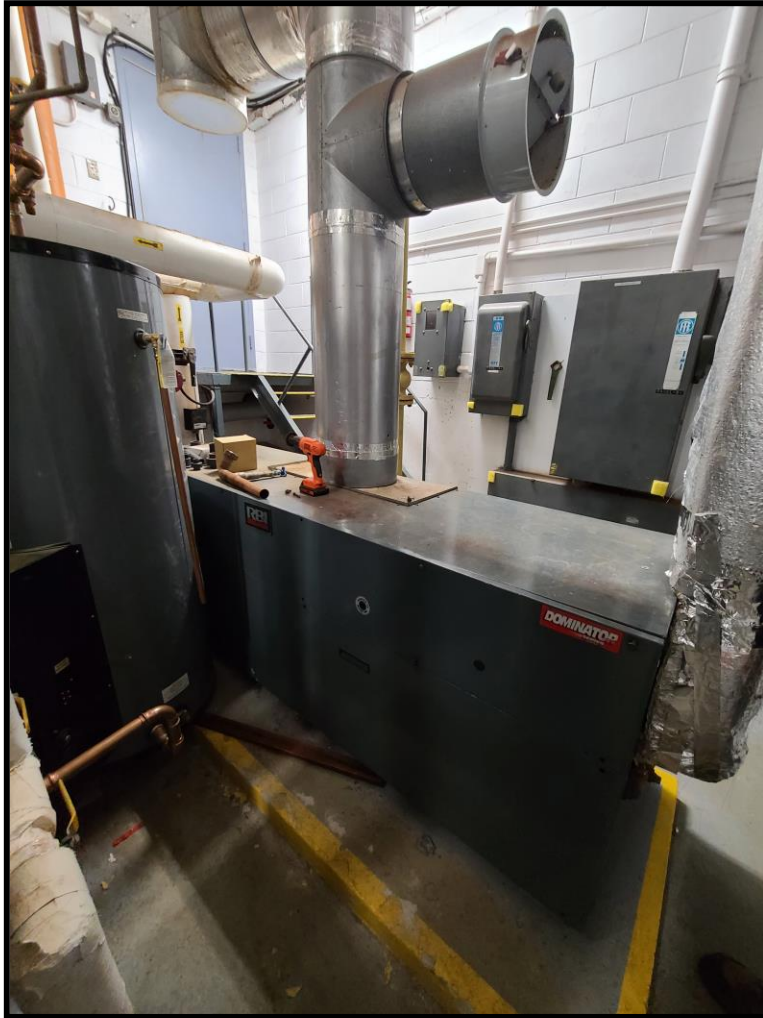
The main heating plant for the facility is a RBI 33DB2100NASS 2,100 MBH boiler. This boiler provides heat to the entire building, as well as for the domestic hot water throughout. This past summer, the unit had failed and it had taken most of the summer to get the necessary parts for repair. A temporary heating plant was installed to provide domestic water through the summer. The parts have recently arrived to repair the boiler.

Fig. 2.3.1: RBI Hot Water Boiler

The boiler is now 20 years old and has reached its life expectancy. A heating plant of this size should be comprised of multiple boilers so that there is redundancy; if one unit fails, there is another unit that can provide heat until the inoperable boiler can be repaired.

As is the case with the air handling equipment in the mechanical room, the heating plant's associated piping is also in very poor condition and is severely rusted in most areas. While some, of this is only surface, but a lot of the valves and joints are corroding and will be prone to leaks.

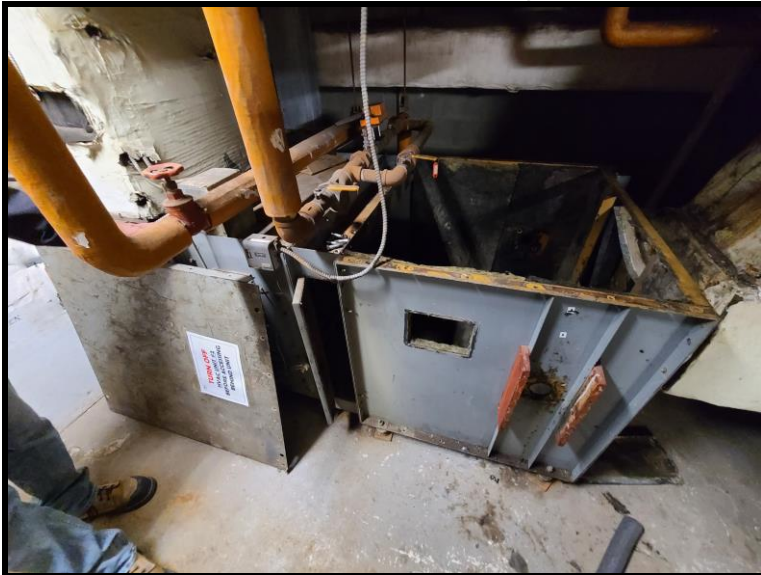
The change rooms, and spectator areas are serviced separately from the air handling units in the mechanical room. These units servicing these areas are now 45 years old with a life expectancy of about 25 years. Parts have been replaced to keep them operational, but none of the controls on the unit function and most of the dampers and valves are operated manually.

Figure 2.4.1 Redundant Air Handler
