MECHANICAL EQUIPMENT ASSESSMENT REPORT WH COLLINS CENTRE HILLSIDE DRIVE NORTH, ELLIOT LAKE, ON

Submitted to: Project No.: Report By: Date: Revision: Don Crain 20M74 Tim Janzen, P.Eng. November 2020 0

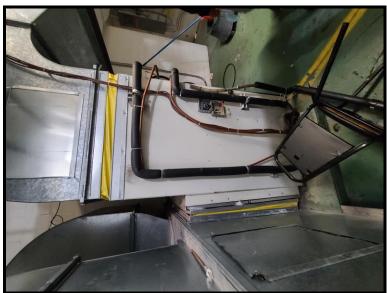
Fig. 2.1.1: Primary Air Handling Unit

The building is serviced by a single air handling unit located in a second floor mechanical room. This unit is the original equipment from when the building was constructed. Heating is provided by 3 medium efficiency modular boilers located in the same mechanical room. Cooling is provided by a DX coil in the ductwork and a remote outdoor condensing unit. The air handling unit can be seen below in Figure 2.1.1.

The air handler can be kept in operation as long as continuous maintenance can occur, but it has surpassed its life expectancy. It still operates to heat and cool the building, but controls are minimal and most of the modulation of the dampers and valves are carried out manually. Heating is accomplished by a hot water heating coil located in the ductwork of this unit. The piping is deteriorating and will also have to be considered for replacement in the near future.

Upgrades could be done to keep the air handler operating, but there are very minimal controls and it is a highly in-efficient unit.

If this building is going to continue to be used, we would recommend that you budget to install a new air handler with a new heating plant which will provide you with energy savings, increased comfort, and reduced maintenance. This may involve a gas fired air handler with the removal of the boiler plant.

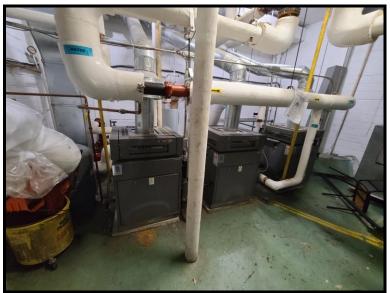
Fig. 2.1.2 Boiler Plant for Heating

The boilers shown below in Figure 2.1.2 appear to be original to the building as well. These boilers are approximately 80% efficient, but are very old and could fail at any time. They were recently re-built with new tubes and heat exchangers. The benefit of this boiler plant is that you have 3 boilers and if one of them were to fail, you still have 2 boilers to provide heat to the building.
