PRELIMINARY STRUCTURAL CONDITION ASSESSMENT

14 Elizabeth Walk – the former “Reel 2
Reel Theatre”

The City of Elliot Lake has retained TULLOCH Engineering to conduct a preliminary structural condition assessment (PSCA) of a commercial property located at 14 Elizabeth Walk, Elliot Lake, Ontario, formerly known as the “Reel 2 Reel” Theatre. The field assessment was conducted on June 10, 2022 with the intent to gather facts to submit a report outlining the overall condition of the structure and any issues related to the structure warranting immediate repair, replacement or remediation. In addition, TULLOCH is providing structural engineering services to support the planned renovation of the Theatre. Where discoveries were made that could affect the renovation as planned, they have been made known in the following report. Observations and photographs drawn from two site visits in April 2022 are included where relevant.

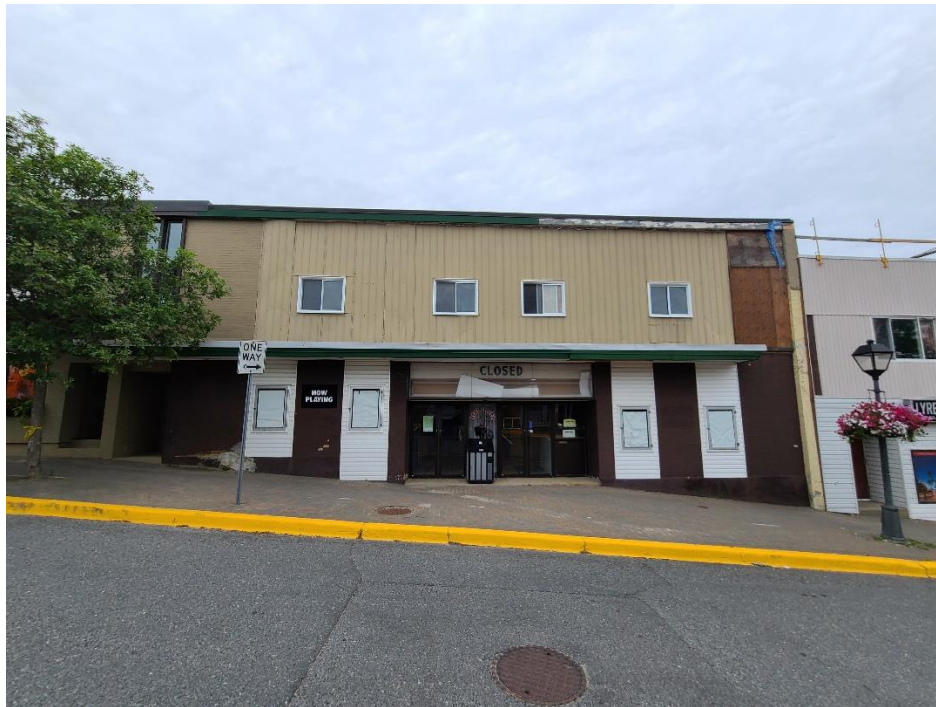
- Main floor exterior wall is loadbearing masonry (CMU), brick infill, vinyl siding “panels” covering older windows, and a central recessed entrance with two sets of double doors and a backlit sign board (Figure 1).

Figure 1 – Street view, south elevation, July 2021. *Source: MET*
