MEMO

To: Recreation and Culture Standing Committee
From: Kari Kluge, Director of Recreation and Culture
Date: January 28th, 2025
Subject: Parsons Park and Rogers Arena Retaining Wall Update

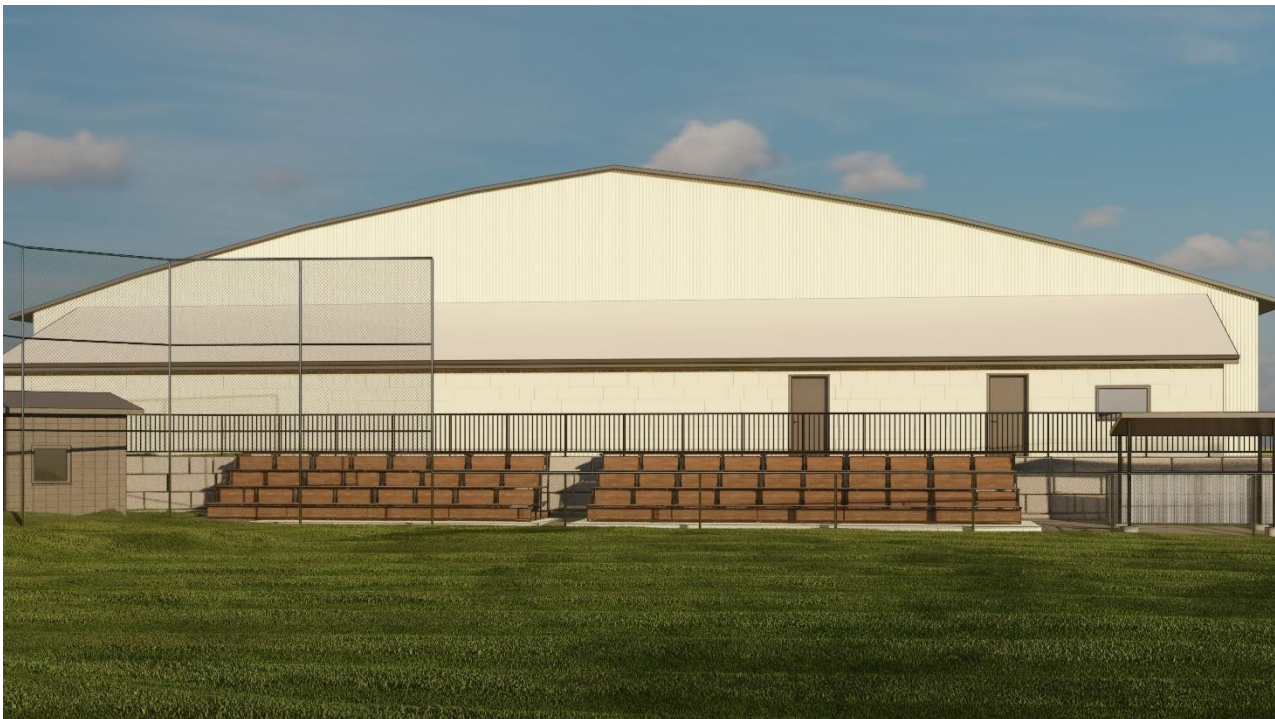
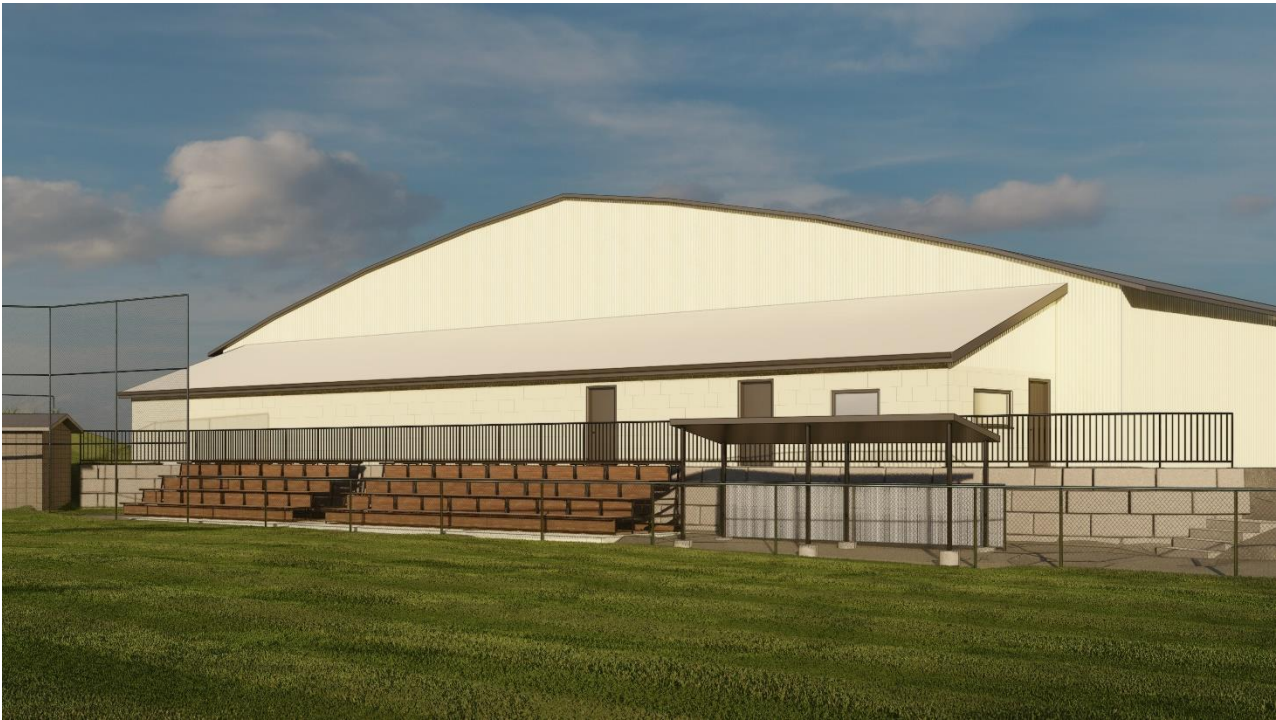
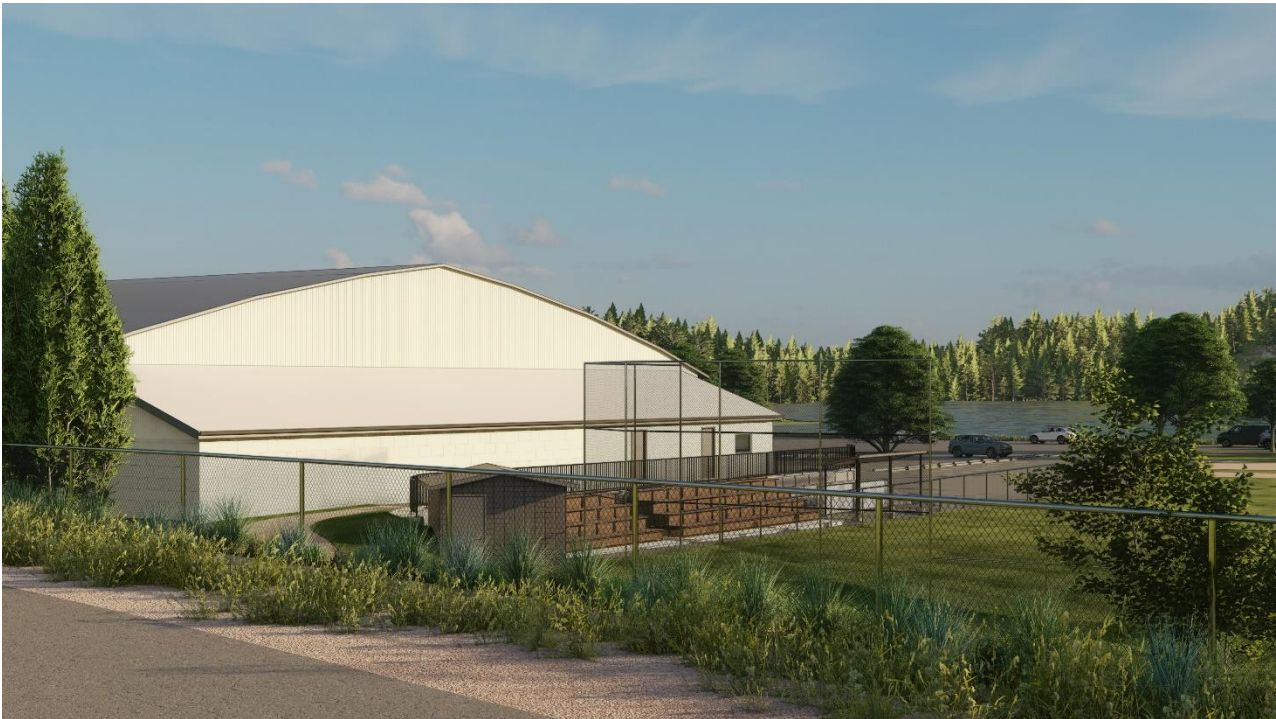
Staff are preparing a Request for Proposal (RFP) based on Tulloch's technical drawings and 3D renderings (see below), with the goal to commence construction of the project in September. To minimize disruption to the Spring/Summer leagues, Staff are exploring options to ensure that play can safely continue at Parsons Park during the on-going construction at Rogers Arena this spring and summer. Temporary bypasses for the seating area are being planned to maintain access, and adjusted parking plans are under consideration to address the limited availability. To mitigate these challenges, users will also be encouraged to utilize street parking on Central Avenue and access the ball diamond via the Central Avenue entrance, in addition to the limited parking spots available in the shared parking lot with Rogers Arena.

In response to these findings, Tulloch Engineering has provided a design plan that addresses these concerns. The proposed plan ensures compliance with AODA standards by incorporating accessible entrances to both sides of the field and viewing areas. It also includes solutions for proper water drainage to redirect runoff away from the field and the arena foundation, as the current drainage channels water from the arena roof directly onto the ball diamond, particularly in the batter box and home plate area. This has contributed to water pooling on the field, often creating unsafe conditions and necessitating game cancellations. Furthermore, the design features railings and appropriate step heights to mitigate fall risks, as well as options to access all spectator areas of the field, including the top and field-level viewing areas on the third base line and access to the spectator area on the first base line.
